Survey on the main defects in ancient buildings constructed mainly with natural raw materials

In this context an early 19th century Portuguese watermill building is used as a study case to show how a roof leaking may lead to a progressive building collapse.

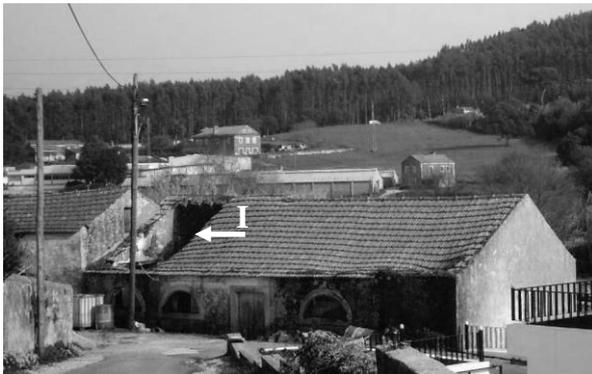
In this research work, the building adopted as a study case is an early 19th century watermill which its main function was to provide the neighborhood and the surrounding villages of flour. Its activity ended by the mid 70's with the boom of the supermarket networks which started to offer pre-packed cereals and flour. The death of the owner plus the above described situation were the main reasons why the watermill building has been without any use and maintenance from that time. The Fig. 1 shows the watermill building in 2000 in which it is evident that a partial roof collapse has occurred (Fig. 1, detail D).

Figure 1. Watermill building's condition in 2000

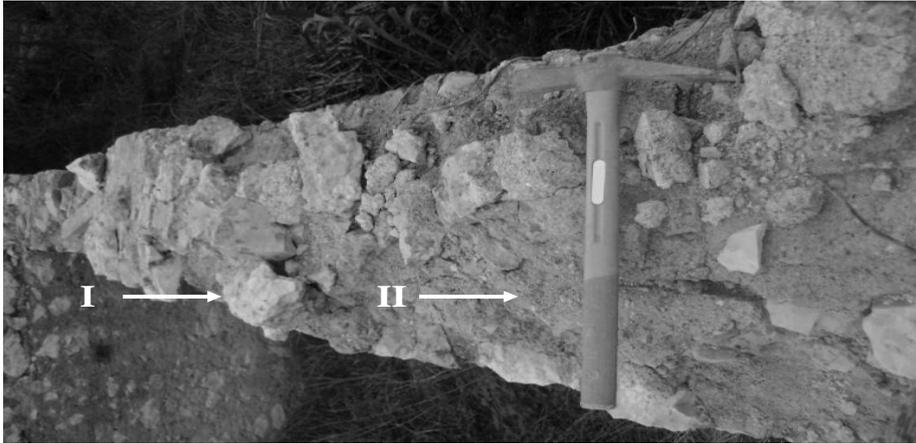
Figure 5. Detail of the structural stone masonries walls

Since this region is sparse in stones, the structural stone masonries walls (exterior and interior) had been built up using irregular and small sized limestone pieces (Fig. 5, detail I) agglutinated by a structural mortar (Fig. 5, detail II). The average thickness of these walls is 0.40 m.

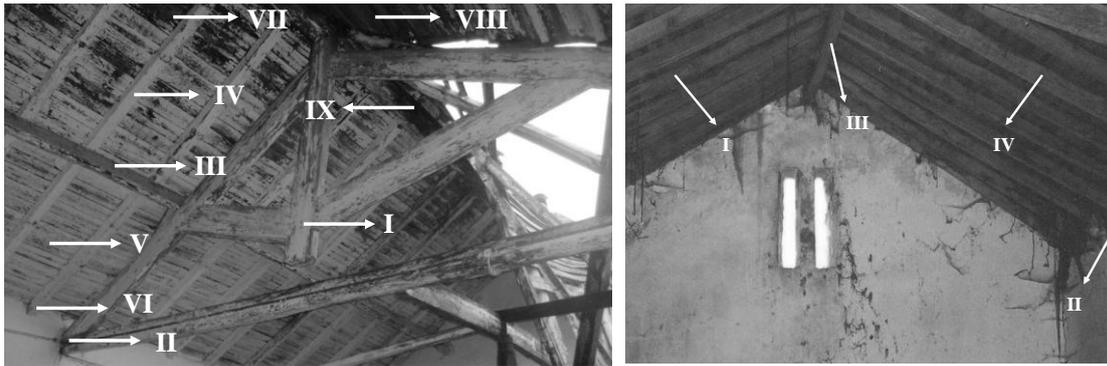
a. Trussed type roof structural solution
Figure 6. Roof structural systems

The roof timber structural solution comprises two types. In the grind stone and the command rooms (Fig. 6-a) it was adopted trusses (Fig. 6-a, detail I) directly supported on the limestone based masonries walls (Fig. 6-a, detail II), these trusses support beams (Fig. 6-a, detail III) which are supporting the purling (Fig. 6-a, detail IV). On the purling there are timber boards (Fig. 6-a, detail V) supporting the ceramic tiles.

The other type of roof timber structural solution was only applied in the storage room, Fig. 6-b, which includes timber beams (Fig 6-b. detail I) which were structures supported on the limestone based masonry walls (Fig. 6-b, detail II) and a central timber beam (Fig. 6-b, detail III). On these timber beams there were timber boards (Fig.6-b, detail IV) supporting the ceramic tiles.

Meanwhile, Figure 8-a illustrates the roof's condition of the grindstone room before the above described third roof's structural collapse occurred in 2009 (Fig. 8-c). Some purling and timbers boards showed an advance stage of deterioration in the contact zone with the structural wall. Through Figure 6-a, detail I, it is also possible to notice that these timber elements had a darker shade than the similar ones located outside of the damaged zone which indicated a leaking problem. By doing a similar analysis, Figure 6-a, details VII, VIII and IX indicated that there were some cracked ceramic tiles or the ceramic tiles/timber board direct contact solution was not the appropriated one because may increase an undesirable water moisture in the timber structural elements.

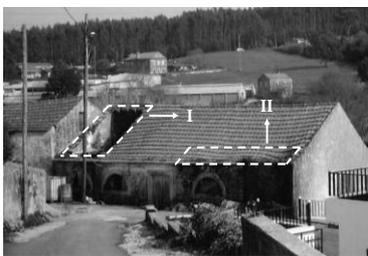
a. 1st Collapse (2000)

The roof timber structure has been facing partial collapses throughout the last 9 years. The first partial collapse occurred in 2000, in which part of the roof of the storage room was lost (Fig. 8-a, detail I). It is important to underline that the main structural timber elements which are trusses did not get damaged.

Figure 8-a in its detail II shows a local permanent deformation of the roof system of the grindstone room in its connection to the frontal wall. Some ceramic tiles were also missing there.

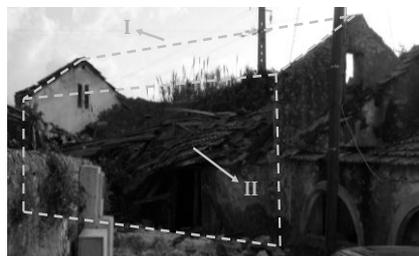
b. 2nd Collapse (2007)

The second structural failure of the roof occurred in 2007 resulting in the completely loss of the roof of the storage room (Fig. 8-b, detail I) and part of the frontal limestone based masonry wall (Fig. 8-b, detail II).

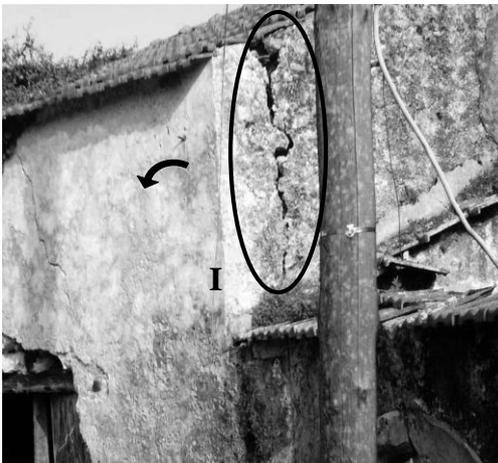
An expressive vertical crack located in the junction of two limestone based masonry wall of the storage room (Fig. 9, detail I) was formed just before the occurrence of the second roof's structural collapse occurred in 2007. The thickness of this vertical crack decreases from the top to the bottom.

Figure 9. Vertical crack, 2007
