Reinforcement methodology applied in buildings damaged by the Azores earthquake

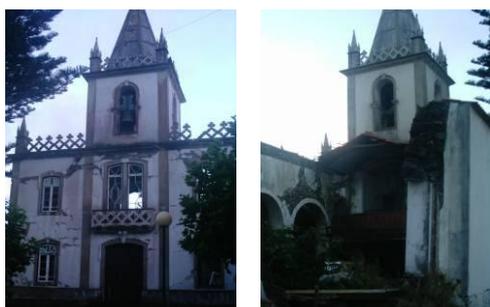
Figure 2: Ribeirinha church.

The most devastated area was the area of the Ribeirinha (Figure 2), in the Faial Island, the closest area to the earthquake epicenter. A vast part of the island constructions was destroyed, mostly because of the traditional weak seismic resistant constructions. The religious buildings, built with constructive methodologies similar to traditional buildings, suffered also great damages. The bridges also had great damages and the constructions closest to the epicenter were intensely damaged (Figure 3). The modern constructions didn't register several damages.

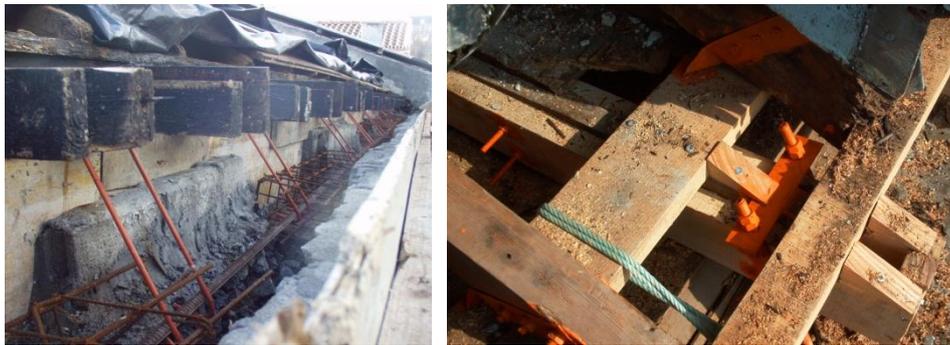
Figure 4: Crowning belt application (Barros et al. 2005).

The objective of using crowning belts, see Figure 4, was to distribute the seismic horizontal forces, to tie the façade walls enabling a box behavior, to distribute the vertical loads and to reduce the roof displacements, that is to say, to confine and improve the seismic behavior of the structure.

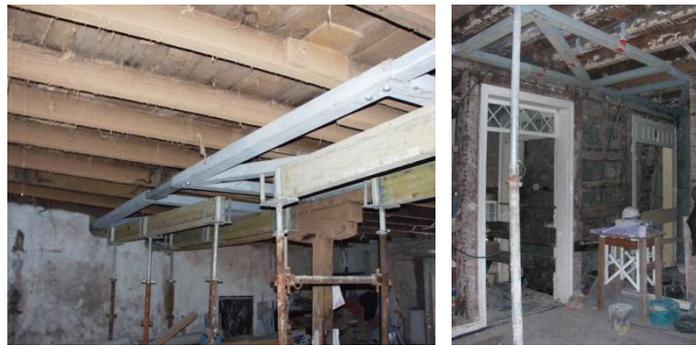
Figure 5: Metallic trusses (Barros et al. 2005).

The trusses component, Figure 5, is constituted by metallic profiles, of hollow rectangular section, usually prefabricated. This allows saving time in the work execution, as well as it facilitates the assembly. The metallic trellis receives the forces transmitted by the intermediate braces and it transfers them to the extremity supports, the two perpendicular walls in which it leans on.

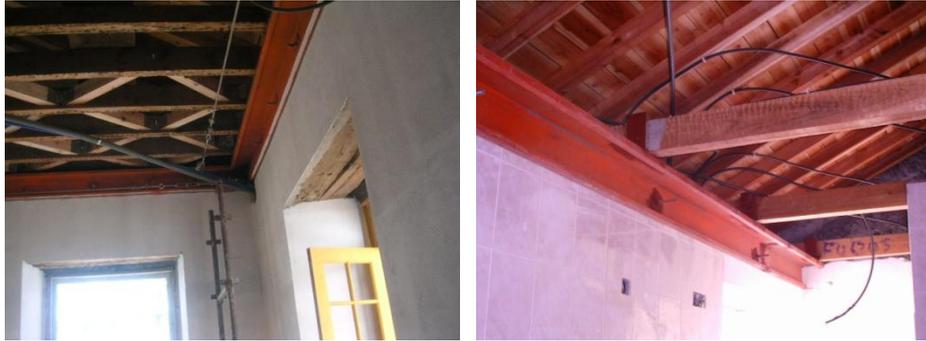
Figure 6: Curve foil (Barros et al. 2005).

There were used a huge number of foil types (Figure 6) that can be used in the anti-seismic reinforcement. The folded foil is one of the most used types in the seismic reinforcement; it is a foil in elbow form that serves to support the wood beams, and at the same time allows to do the connection between the bottom walls and the floor.

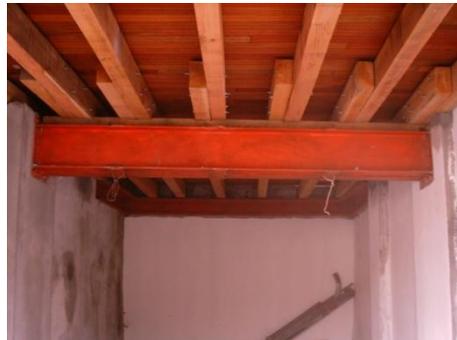
Figure 7: Metallic beams (Barros et al. 2005).

The metallic beams (Figure 7) were used to substitute the deteriorated pieces, or to reinforce weak areas of buildings. Their functions are similar to the beams applied in new buildings.

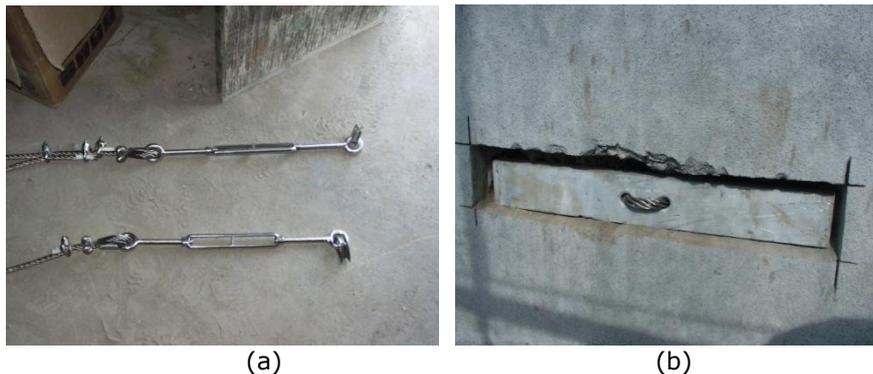
Figure 8: Iron ties: (a) Iron ties; (b) Iron Ties anchorage (Barros et al. 2005).

The iron ties (Figure 8 (a)) are usually made of stainless steel and work on tension, either having passive or active structural functions. However, their function, when used as an anti-seismic reinforcement, is usually passive, being activated only by an earthquake. The ties anchorage (Figure 8 (b)) is made by the external part of the walls, made through fastening bars usually in steel.

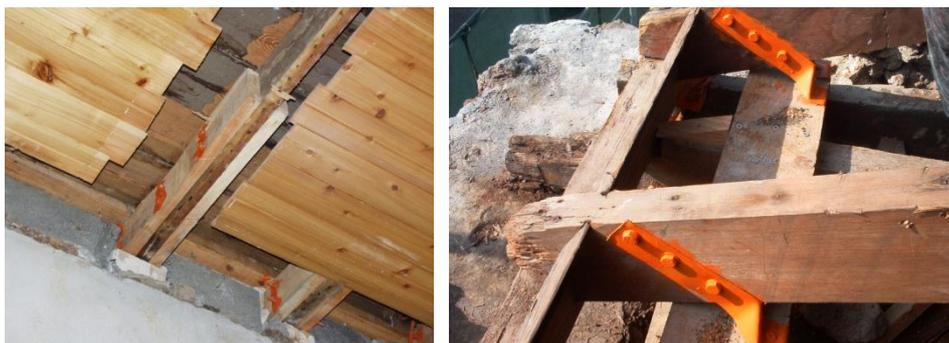
Figure 7: Metallic beams (Barros et al. 2005).

The screwed connections (Figure 9) are connections made by metallic screws that allow connecting the metallic elements with the existent building structure. These are extremely important connections, because they allow guaranteeing the safety and the good behavior of the remaining metallic elements used in the seismic reinforcement.
