Post-earthquake damage classification and assessment: case study of the residential buildings after the $M_w = 5$ earthquake in Mila city, Northeast Algeria on August 7, 2020

Hamidatou Mouloud¹ · Amar Chaker² · Hallal Nassim¹ · Saad Lebdioui³ · Hugo Rodrigues⁴ · Matthew R. Agius⁵

Abstract

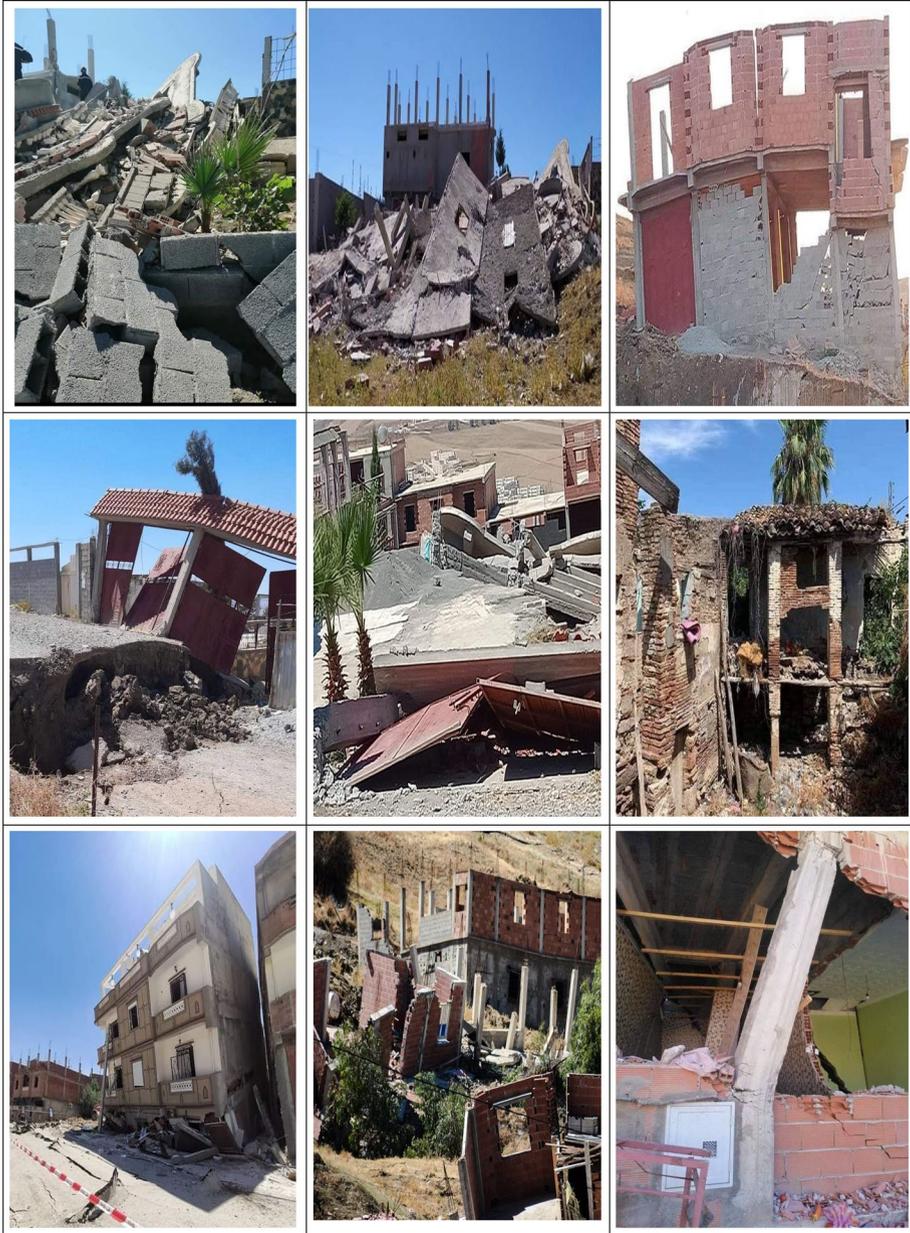
Fig. 1 Illustration of typical structure damage following the Mila earthquake

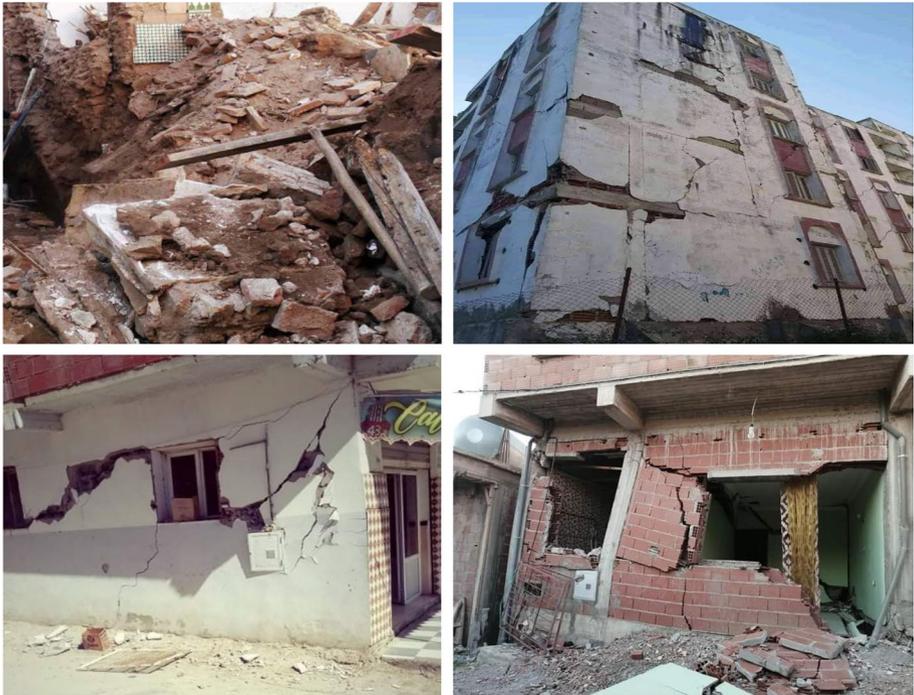
Fig. 14 In-plane and out-of plane damage

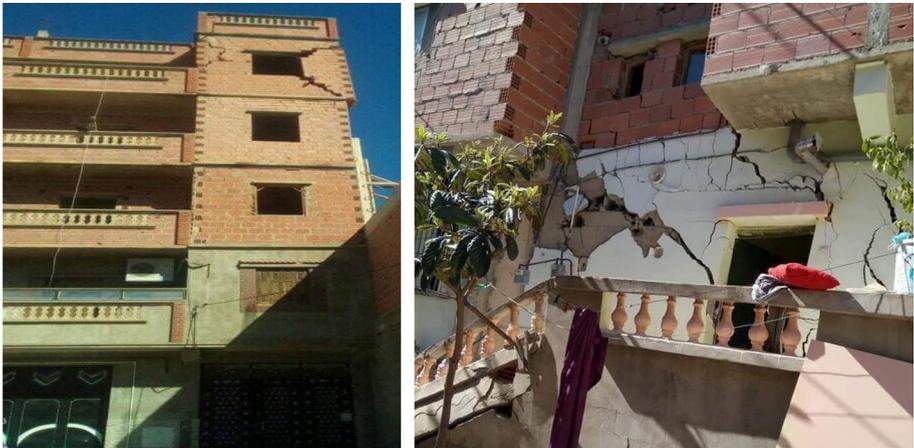
Fig. 15 Plan irregularities caused damage to the connecting components

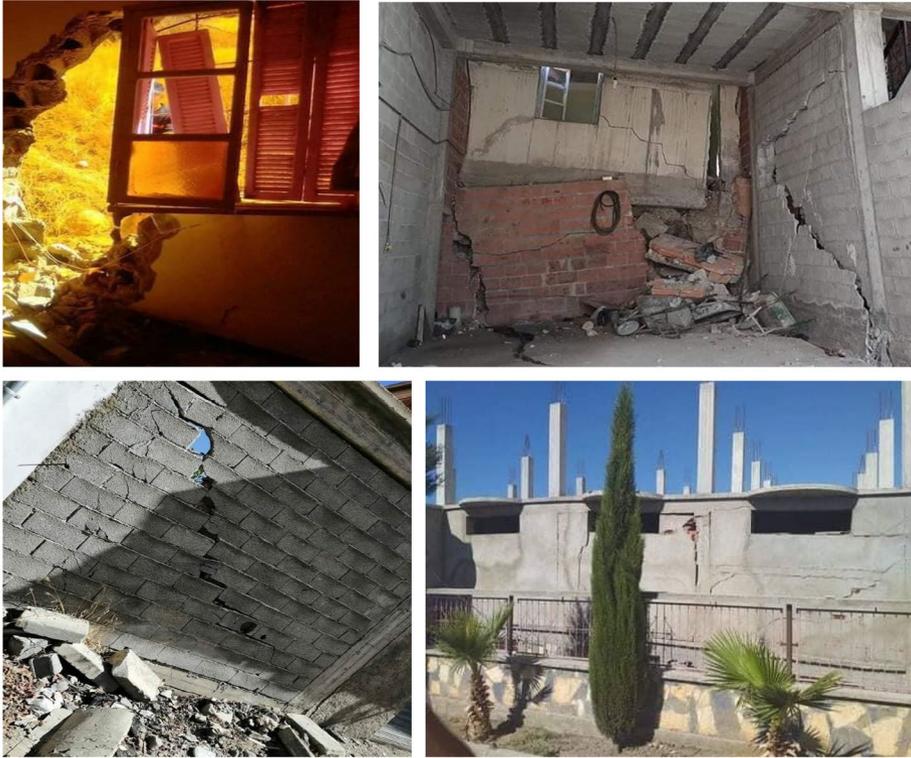
Fig. 16 Damage to partition walls

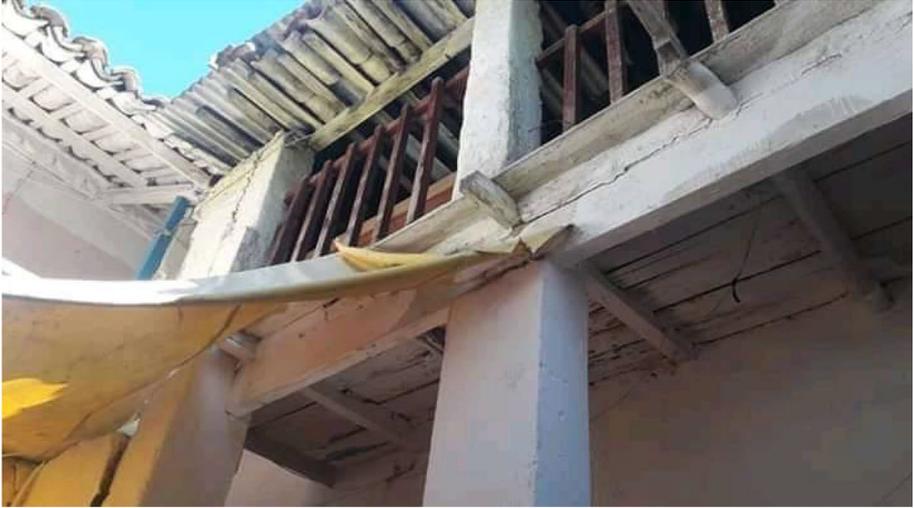
extensively modified during the conversion of attics to residential use. Timber tie components were frequently cut to install a door (Fig. 17), creating significant alterations to the roof structure's basic structural system.

Fig. 17 An example of an attic conversion for residential use

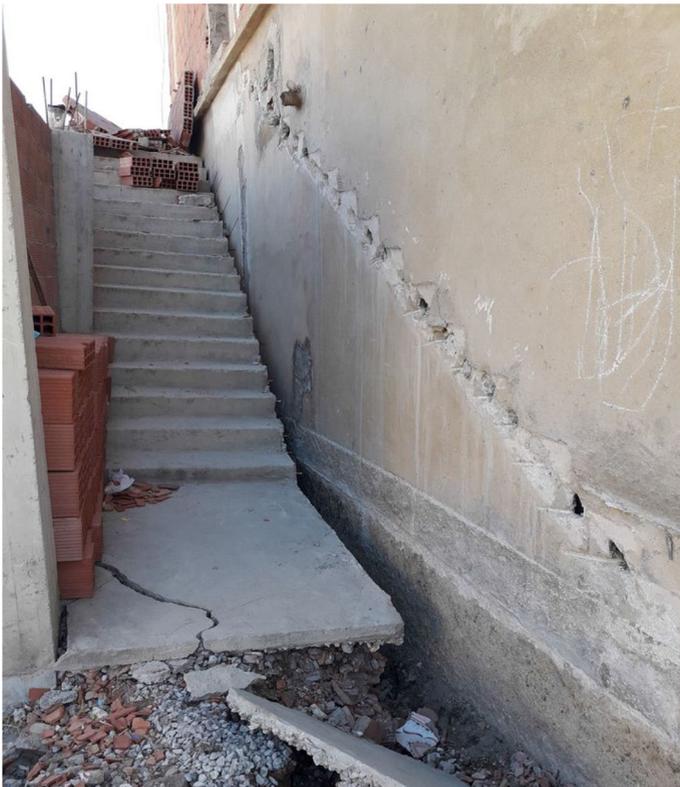
Stairs in residential structures are often positioned in the center of the floor layout, with various residential units on either side. Stairs are not necessarily non-structural features, but in the case of brick structures in Mila, they are not critical for seismic force resistance. Stairs can be monolithic at times, although they are usually fixed to the walls on one side and supported by steel profiles on the other. Many stairs lack a supporting beam and are not monolithic, as seen in Fig. 18 (right). Staircase walls are often thicker and part of a rigid core. The most typical staircase damage is the separation of individual stairs, the falling of plaster (sometimes as thick as 3 cm), and the separation of the stairs from the walls (Fig. 18).

Fig. 18 Typical stairwell damage

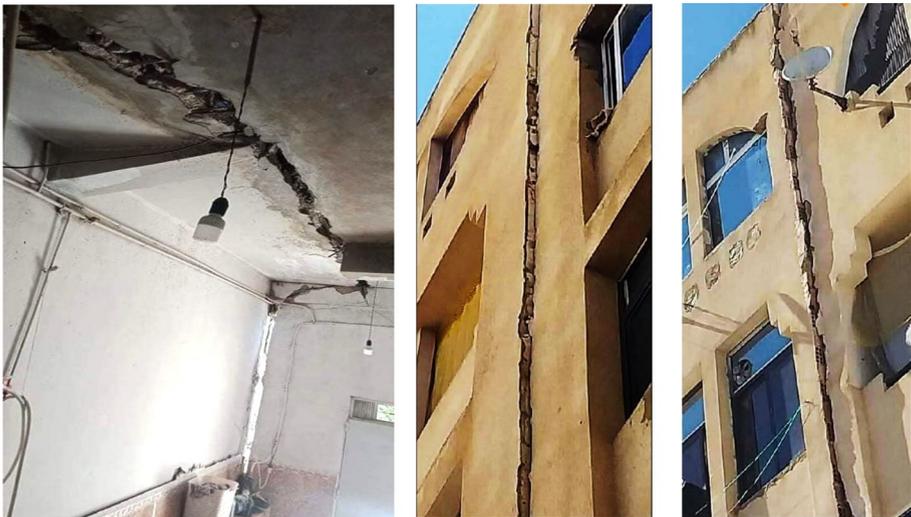
Fig. 19 Typical elevator shaft damage

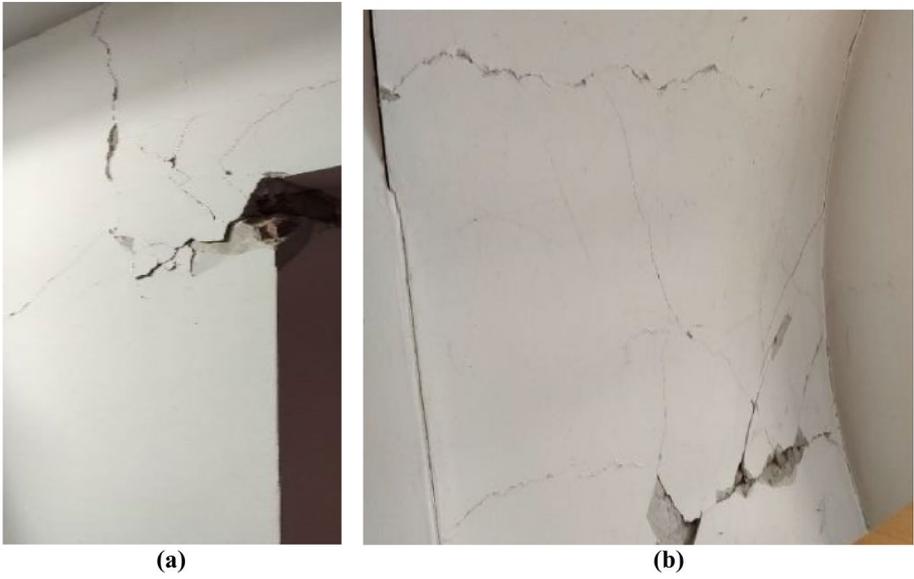
- On all levels, there is apparent damage in the form of cracks in the wall coverings, arches (Fig. 21a), vaults, and ceilings (Fig. 21b);
- Plaster separation and localized damage;
- Structural components (walls, columns, and arches) have minor damage;

Fig. 21 First floor cracks: wall, lintel (a), and ceiling (b)

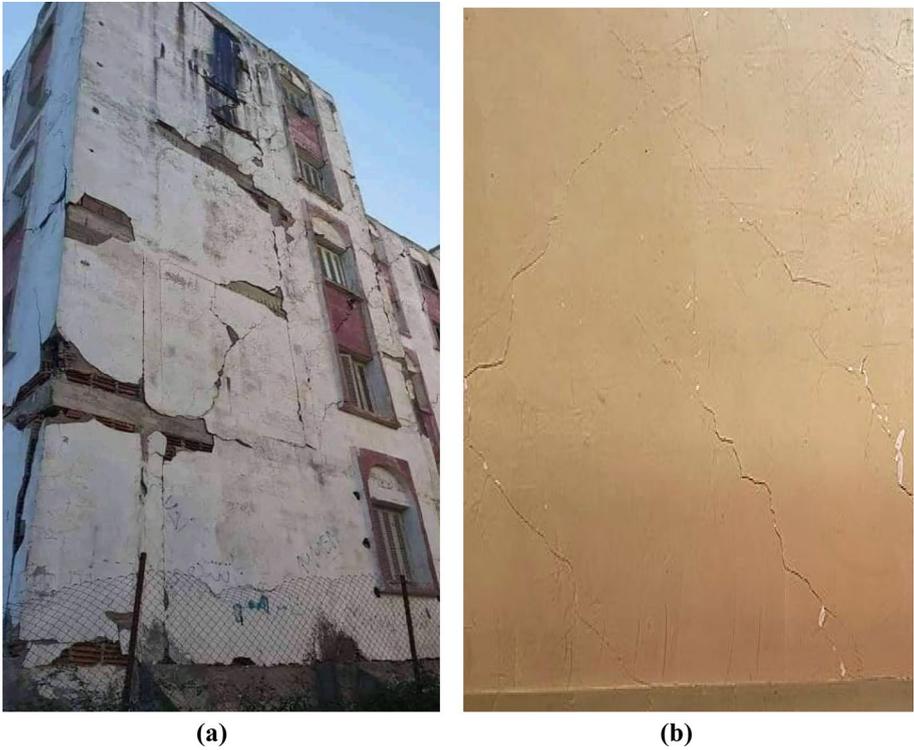
Fig. 22 Exterior a and internal b cracks on the eastern stairwell

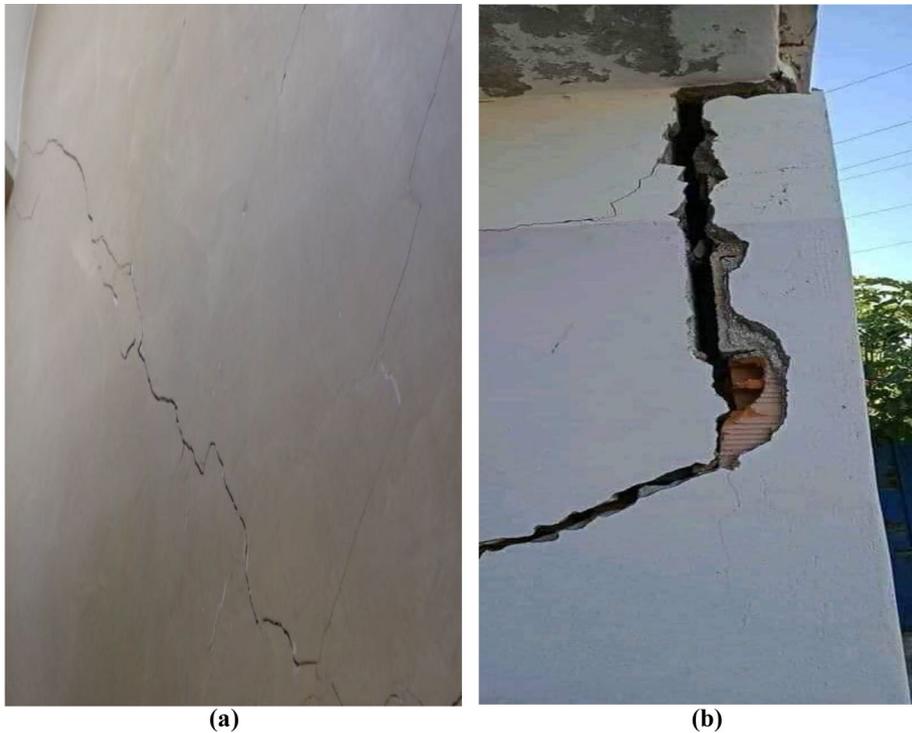
Fig. 23 Exterior **a** and internal **b** diagonal cracks on the central staircase

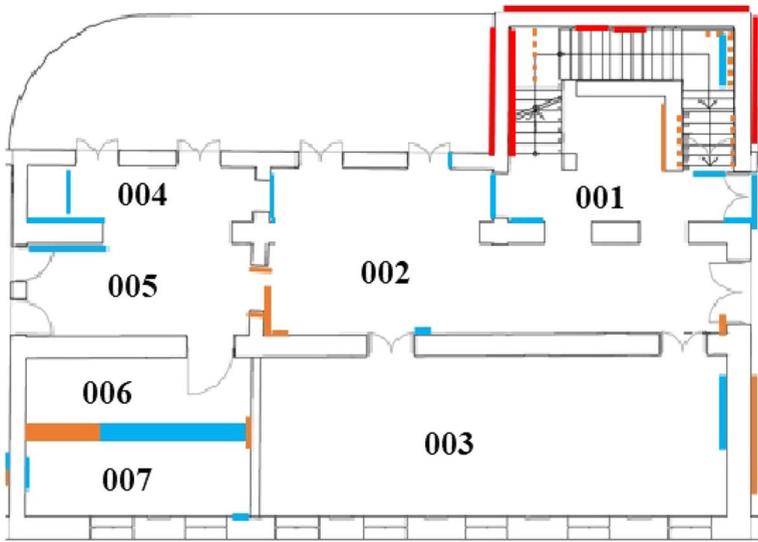
Fig. 24 Damage pattern and shear strength-testing locations on the building’s ground floor

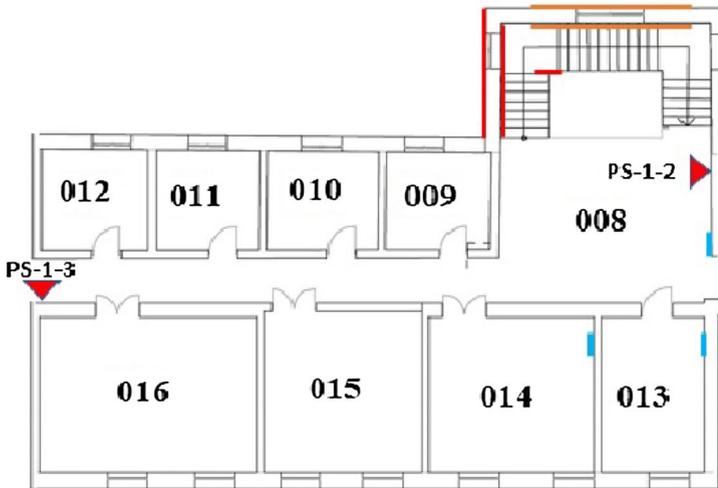
Fig. 25 Damage pattern and shear strength-testing locations on the first level of the structure

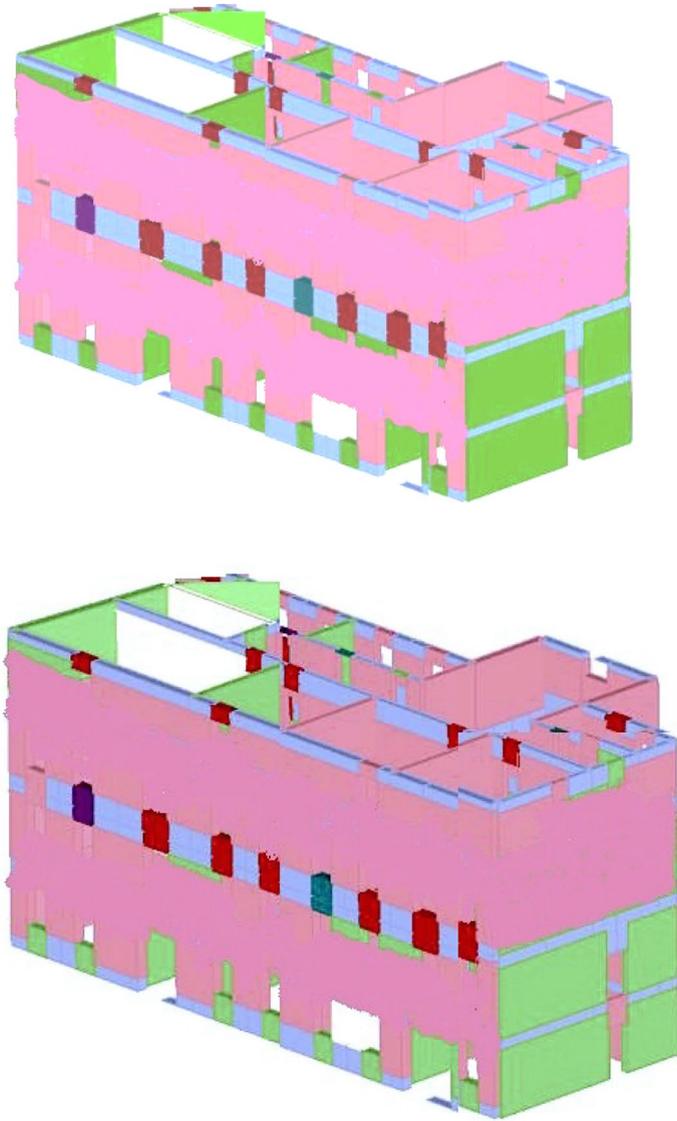
Fig. 32 Damage at maximum displacement capacity for x-direction pushover. Yellow: shear damage, red: bending damage

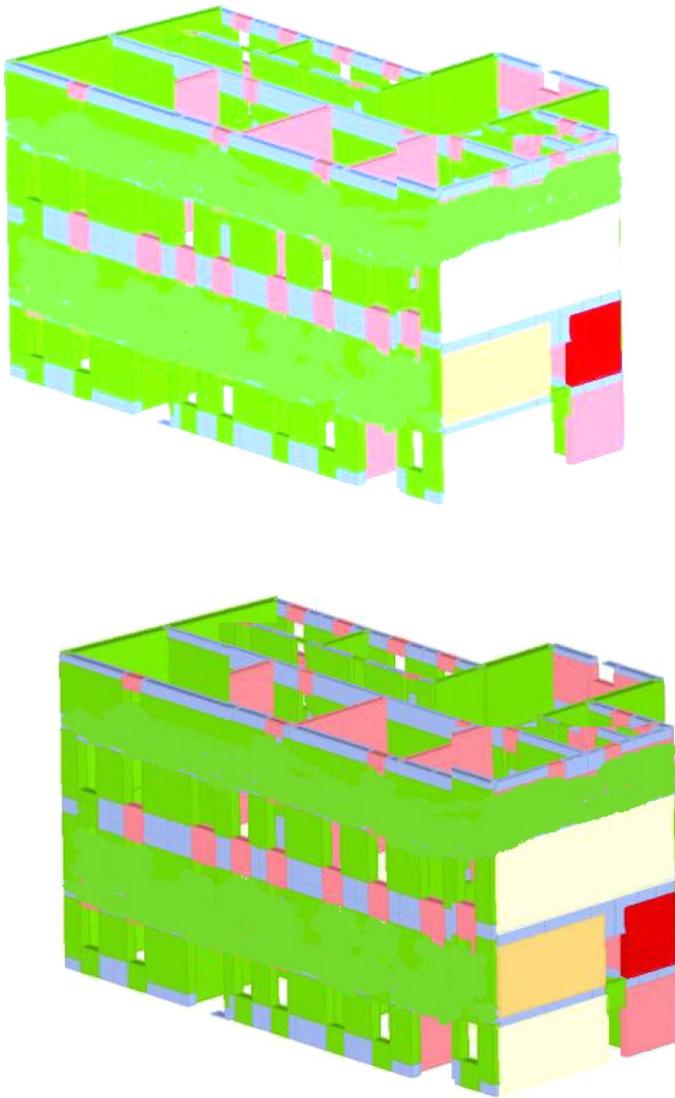
Fig. 33 Damage at maximum displacement capacity for y-direction pushover. Yellow: shear damage, red: bending damage

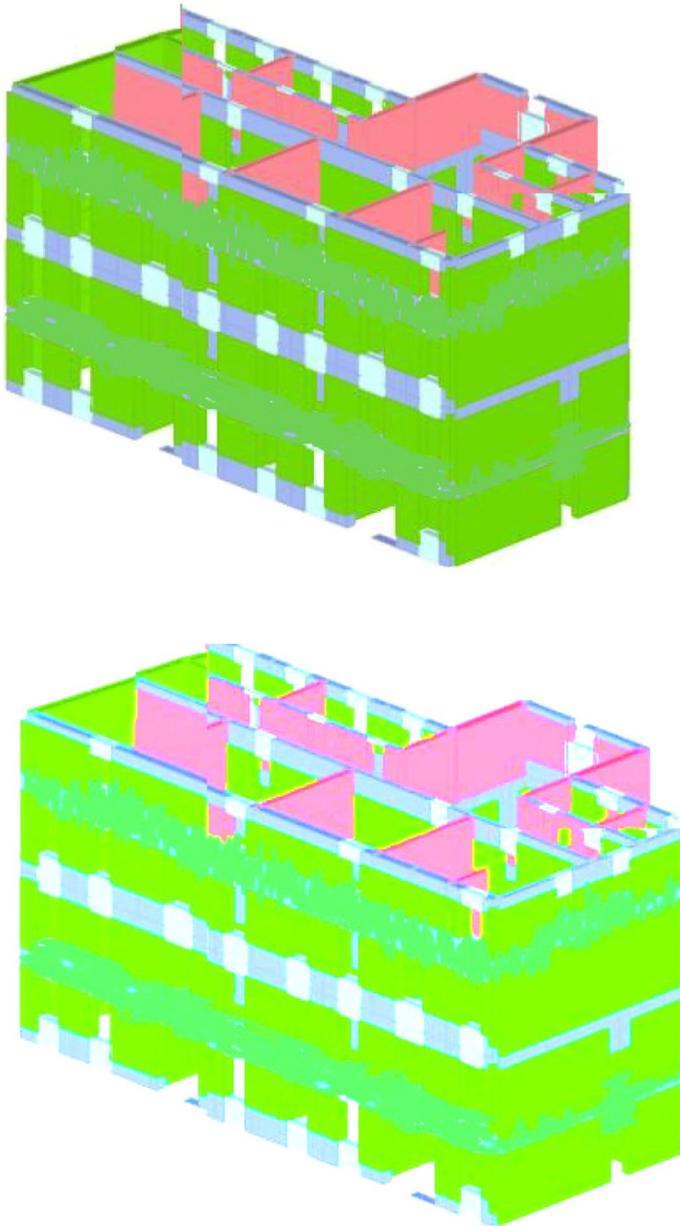
A study of the walls out-of-plane bending must then be performed. This explains the earthquake activity that occurs perpendicular to the walls. The investigation is carried out for the limited situation that is on the verge of collapsing. Acceleration for a 475-year return period is used. If a wall's MRd/MEd ratio is greater than or equal to 1.0, it is considered to have passed the out-of-plane bending test. In Fig. 34, the walls that failed the examination are shown in red.

Fig. 34 Out-of-plane bending findings. Red: bending damage
