Advantages of using raw materials in ancient and recent buildings

In the context of sustainable building construction an early XX century Portuguese watermill building is used in this research work as a study case to show how a roof leaking may lead to a progressive building collapse.

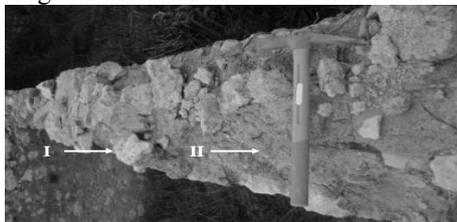
Fig. 4.1. Detail of the structural stone masonries walls

Since this region is sparse in stones, the structural stone masonries walls (exterior and interior) had been built up using irregular and small sized limestone pieces (Fig. 4.1, detail I) agglutinated by a structural mortar (Fig. 4.1, detail II). The average thickness of these walls is 0.40 m.

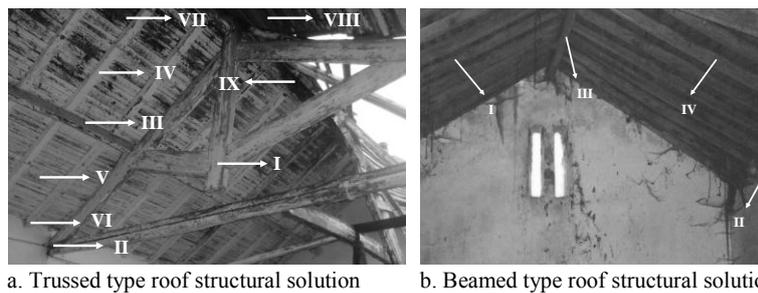
Fig. 5.1. Roof structural systems

The roof timber structural solution comprises two types. In the grind stone and the command rooms (Fig. 5.1-a) it was adopted trusses (Fig. 5.1-a, detail I) directly supported on the limestone based masonries walls (Fig. 5.1-a, detail II), these trusses support beams (Fig. 5.1-a, detail III) which are supporting the purling (Fig. 5.1-a, detail IV). On the purling there are timber boards (Fig. 5.1-a, detail V) supporting the ceramic tiles.

The other type of roof timber structural solution was only applied in the storage room, Fig. 5.1-b, which includes timber beams (Fig 5.1-b. detail I) which were

structures supported on the limestone based masonry walls (Fig. 5.1-b, detail II) and a central timber beam (Fig. 5.1-b, detail III). On these timber beams there were timber boards (Fig. 5.1-b, detail IV) supporting the ceramic tiles.

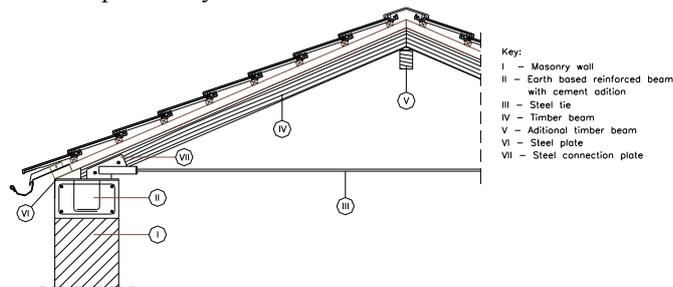
Fig. 7.2. Structural reinforcement solution of the roof of the storage room

An expressive vertical crack located in the junction of the two limestone based masonry wall of the storage room (Fig. 6.2, detail I) was formed just before the occurrence of the second roof's structural collapse occurred in 2007.

In order to mitigate the structural failure seen in Figure 6.2, a structural reinforcement solution is proposed in Fig 7.2 which includes a steel tie (Fig. 7.2, detail III) and an earth based reinforcement beam (Fig. 7.2, detail II) as additional struc-

tural elements. It is also considered that the timber beams should have a horizontal contact surface with the wall. The structural reinforcement of the junction of the masonry walls may be done according to Figure 7.3 in where the lengths a and b need to be specifically calculated.

On the base of achieving a sustainable construction solution, the steel element proposed above should be a reused one.
