Retrofitting solution for beam-to-column connections of precast reinforced concrete industrial buildings

Hugo Rodrigues^{a,*}, Nádía Batalha^b, André Furtado^c, António Arêde^b, Romain Sousa^{a,d}, Humberto Varum^b

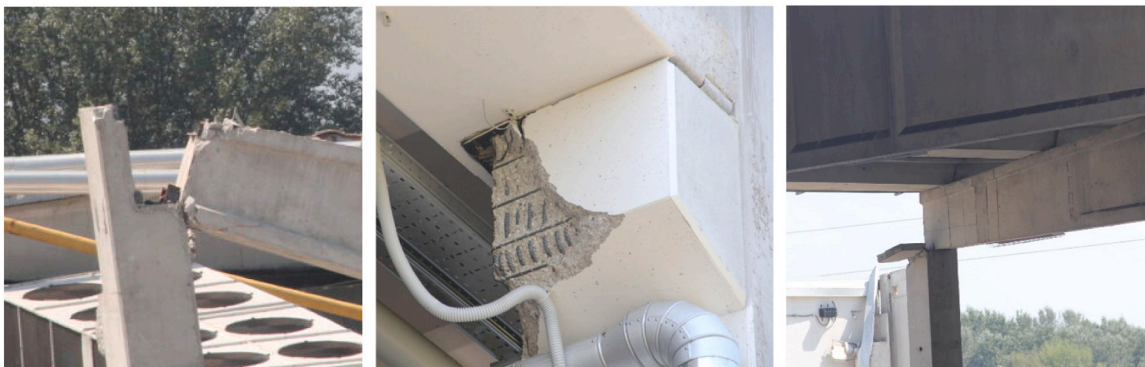
Fig. 1. Examples of beam-to-column connection failures in precast industrial buildings.

Precast reinforced concrete (PRC) industrial buildings are a common typology in the European industrial park. Recent seismic activity has exposed the vulnerability of these types of structures at both structural and non-structural levels. The damages observed in the beam-to-column connections stand out at a structural level. Connections are usually ensured by friction (i.e. concrete-to-concrete) or using neoprene between the concrete interfaces) or by friction combined with a mechanical connector (i.e., dowel). However, the most vulnerable beam-to-column connections are those provided by friction and those with mechanical connectors but designed with low seismic demands in the regions surrounding the dowels [1,2]. Some examples of beam-to-column connection failures are presented in Fig. 1.

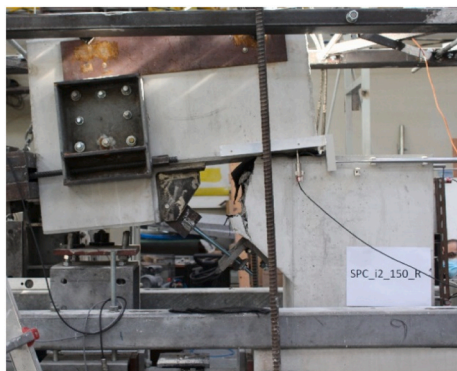
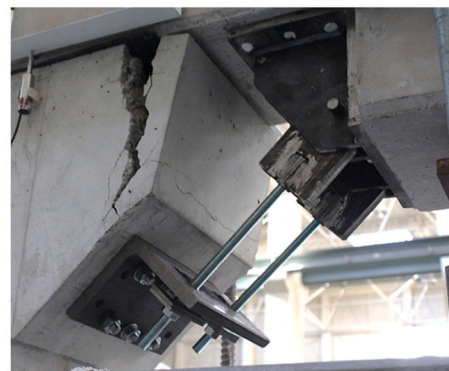
a) Beam rotation

b) Corbel damages

Fig. 4. Damage to specimens with initial setup (before adjustments).

Initially, was considered the same setup used in the first part of the experimental campaign, but after the first test it was concluded that it would not work in the same way. From Fig. 4a), it can be observed that during the test, the beam excessive rotation was evident due to the retrofit solution that introduced a force that ended up pulling the beam towards itself, ending up rotating around the axis perpendicular to the plane that was see in the figure. This rotation created an increase in tensions on the edge of the corbel, causing fragility and ending up with cracks in that same area (Fig. 4b). The retrofit turned out not to be effective in this situation because the test ended prematurely as the damage appeared precisely in that area of the corbel and the corbel ended up collapsing through the detachment of the concrete (Fig. 4b).

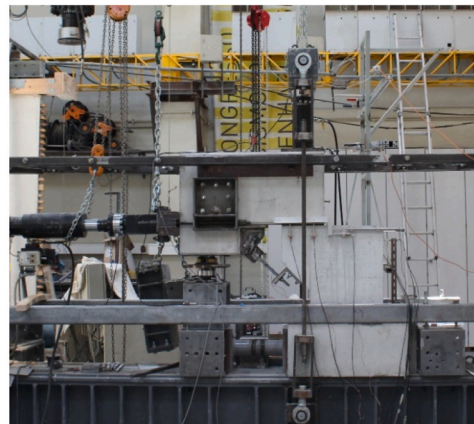
a) Schematic layout

b) General view

Fig. 5. Testing setup for retrofitted specimens at LESE laboratory.

In this sense, it was considered to support the beam so that when the actuator is pulling the beam it does not rotate, which is an approximation to the real situation. The setup was developed to prevent the rotation at the joint and the tests were performed for pure shear behavior of the connection. In this way, the phenomena associated with the shear deformation alone could be studied. It should be noted, however, that in real structures there might be rotation at the joints, caused mainly by the deflection of the columns. Large joint rotations may reduce the overall shear resistance of the connections, as observed in other experimental tests [27,28]. Fig. 5a) shows the modified scheme, adding the modified

part in red. In addition to this particularity, all the rest of the setup was maintained. Fig. 5b) shows the modified setup.

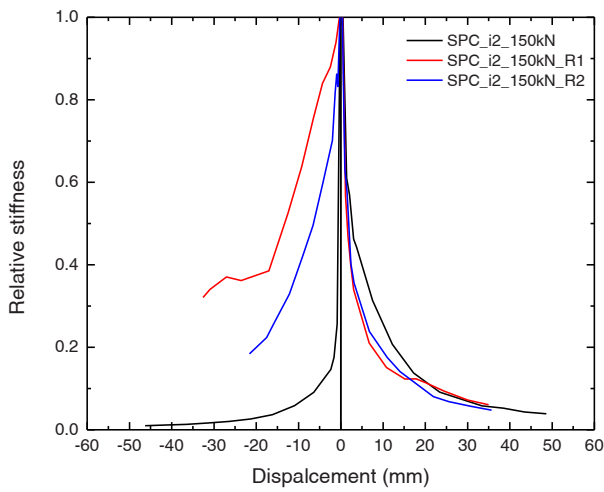
Fig. 12. Comparison between: a) relative stiffness and b) maximum strength.

The evolution of stiffness degradation (Fig. 12a) was assessed by comparing the peak-to-peak secant stiffness of the first cycle for each imposed peak displacement in the positive and negative directions, aiming to understand the impact of the retrofitting.

In Fig. 12b) it is presented a comparison between the maximum strength reached by the three specimens in both push and pull directions. Concerning the push directions, the results are very similar being the higher shear strength reached by SPC_i2_150kN with

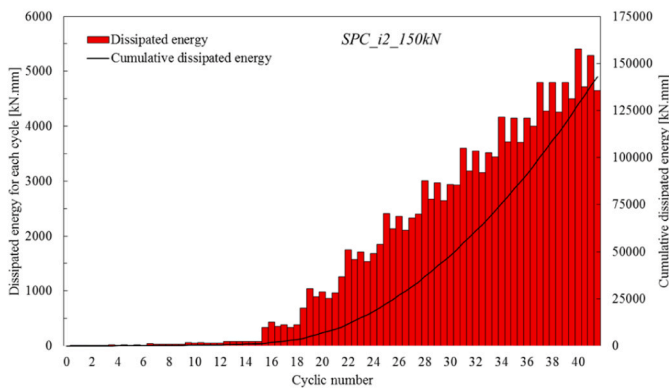
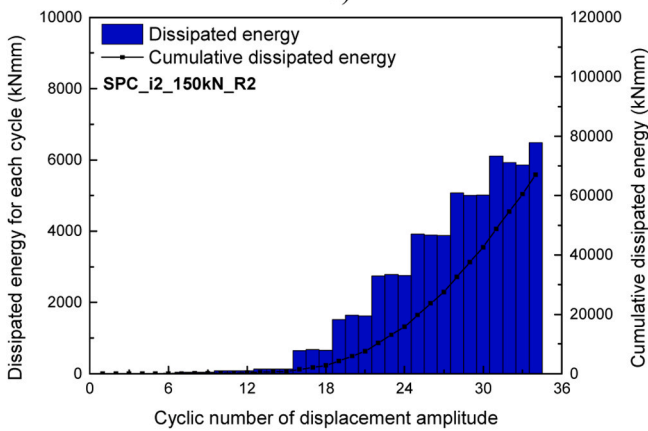
Fig. 13. Dissipated energy per each cycle: a) SPC_i2_150kN b) SPC_i2_150kN_R1; and c) SPC_i2_150kN_R2.

From the analysis of the energy dissipated for each cycle, it can be concluded that the retrofitting contributes to a consistent increase of the

energy dissipation, which is basically due to the area of the half-cycle along the pull direction. A similar shape can be noticed in the plots of the specimens SPC_i2_150kN_R1 and R2, shown in Fig. 13b) and Fig. 13c), respectively. The main difference compared to the reference specimen is that for large displacement demands, the energy dissipation per cycle is constant.
