Common pathologies in RC bridge structures: a statistical analysis

J. Santos, C. Nunes, C. Fernandes & H. Varum

ABSTRACT: One of the main tasks in bridge engineering is to maintain the existing bridge stock according to current and predicted traffic and safety requirements. Bridges deterioration commonly occurs due to a wide variety of pathological factors, with origin in, for example: unexpected traffic loads, vehicle impacts, environmental factors, earth movements, chloride attack, carbonation effect, lack of maintenance, de-icing salts, degradation of the drainage systems, pavement quality. Considering this, a statistical analysis of the most common pathologies in bridge structures, their origin and consequences, was carried out. This analysis was performed considering the pathologies for the overall structure, and for each bridge component. A total of 85 reinforced concrete bridges, representative of the bridge stock in Portugal, were analyzed. Additionally, a comparison of the obtained results with a similar study for Germany was developed. The main differences between the results obtained for each country within this study are pointed out.

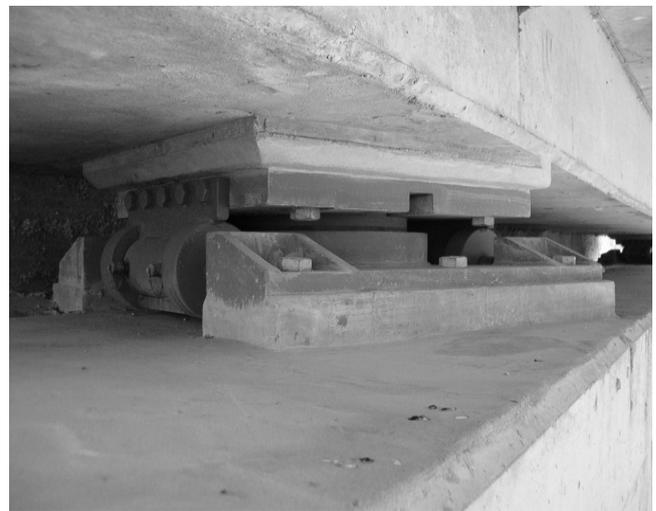
Figure 6. Bearing equipment.

Figure 6 shows the first signs of corrosion in the bearing equipment and also a drainage trench that conduct the water towards the equipment. In Figure 7, the accumulation of construction waste and other fragments evidences the faster degradation of the expansion joints, inhibiting its correct structural function. This indicates the lack of maintenance and misuse of the structure. In Figure 8 it can be observed that the grid spacing is not proper. Thus, waste and fragments will get into the drainage system causing eventually its malfunctioning. Figure 9 shows the cracked wing of an abutment, which allows the water infiltration, instead of conducting it to the drainage system, and possibly affects the structural behavior and soils stability. Figure 10 presents an example of concrete surfaces not accurately finished, leading to potential problems, such as steel reinforcement corrosion and concrete's degradations.

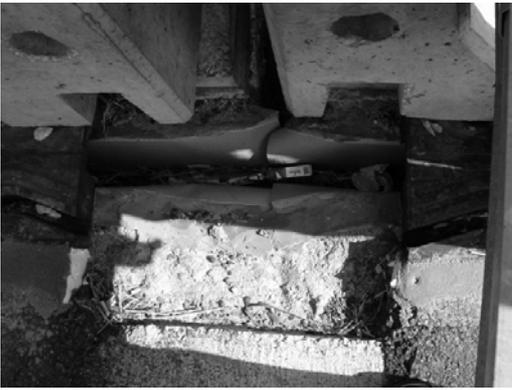
Figure 7. Expansions joints.

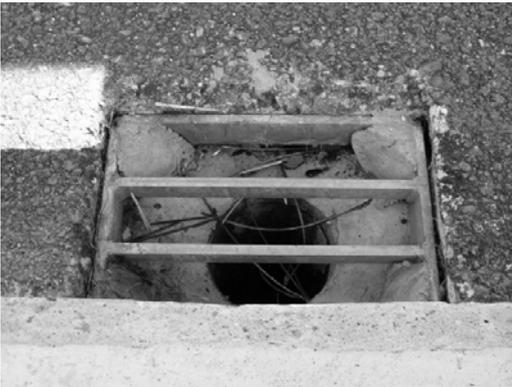
Figure 8. Drainage grids.

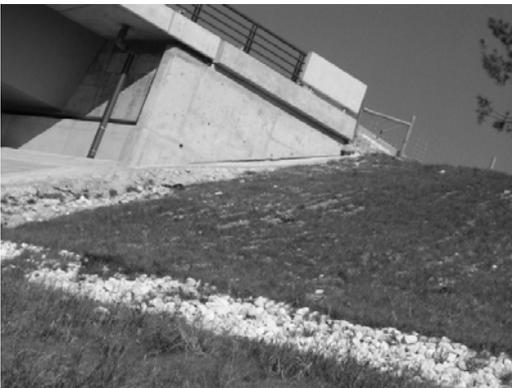
Figure 9. Cracked abutment wings.

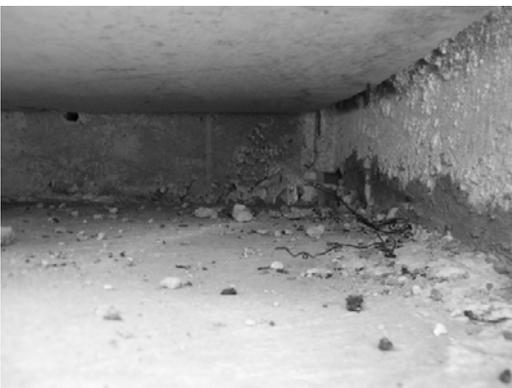
Figure 10. Concrete surfaces improperly finished.
