MECHANICAL CHARACTERIZATION OF ADOBE BRICKS IN EXISTING CONSTRUCTIONS IN AVEIRO REGION, PORTUGAL

Humberto Varum^{1,*}, Tiago Martins^{1,**}

¹University of Aveiro, Civil Engineering Department, Aveiro, Portugal
*hvarum@civil.ua.pt; **a19430@alunos.civil.ua.pt

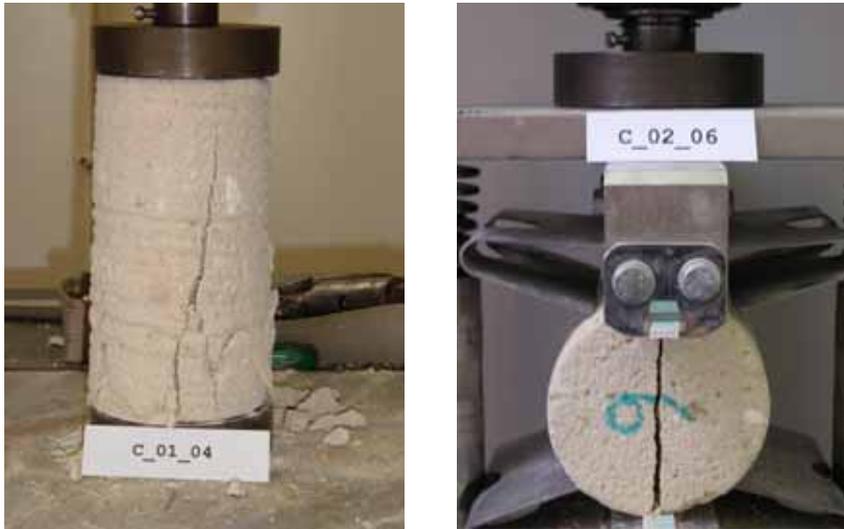
Fig.1 – Specimen's mechanical tests

The diametral compression test was used to estimate the tensile strength of the adobe. A compressive load was applied across the diameter of the specimen creating a nearly uniform state of tension across a vertical plane. Tensile strength of the specimen was measured by increasing the compressive load until the specimen fails in tension. The tensile strength, as described in RILEM CPC6 [9], is given by $\sigma = 2F/(\pi DH)$ [N/mm²],

A total of 40 cylindrical specimens were submitted to destructive tests of mechanical strength, 18 proceeding from houses and 22 from walls. The specimens were divided in two groups, one to perform compression tests, and the other for diametral compression tests, as illustrated in Fig.1.

a) simple compression

b) diametral compression

The compressive strength was determined because it is the most common performance measure used by the engineers in the design and assessment of buildings and other structures. It's calculated from the failure load divided by the cross-sectional area resisting the load and reported in units [N/mm²] as described in RILEM CPC4[9].
