The role of the openings in the out-of-plane behaviour of masonry infill walls

André Furtado^a, António Arêde^a, Hugo Rodrigues^{b,*}, Humberto Varum^a

^a CONSTRUCT-LESE, Department of Civil Engineering, Faculty of Engineering of the University of Porto, Portugal

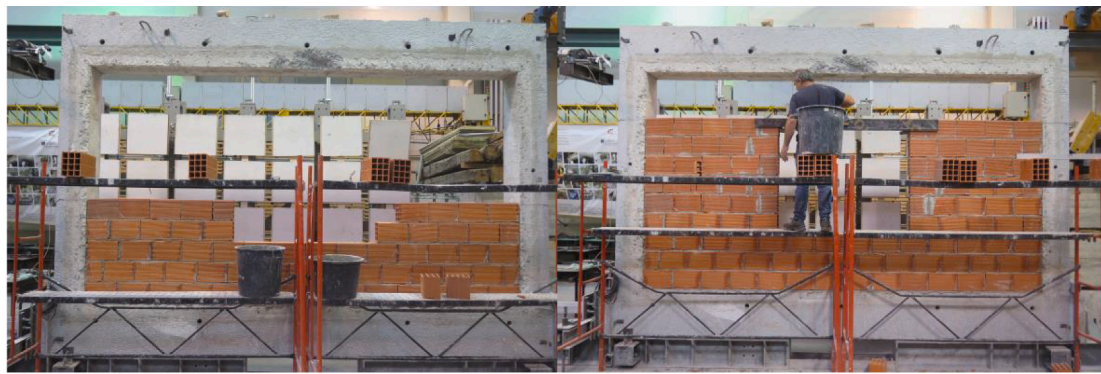
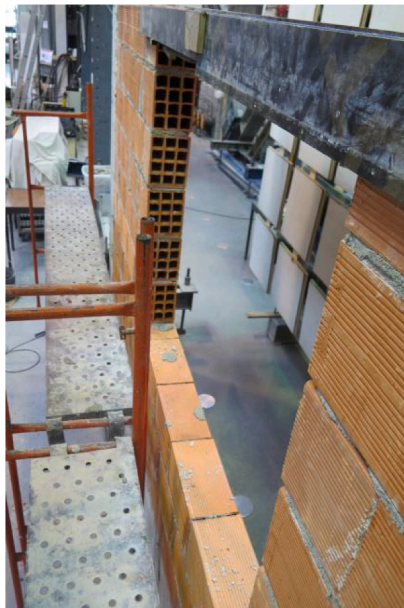
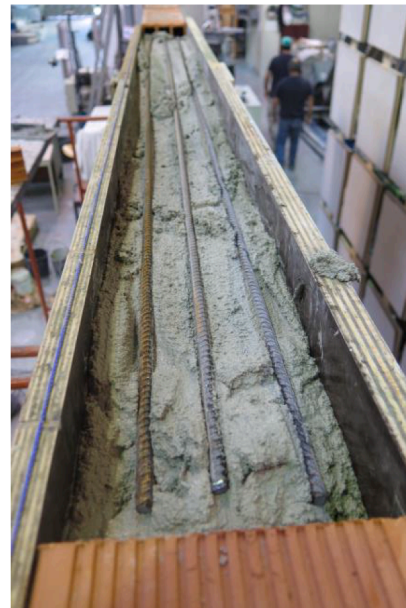
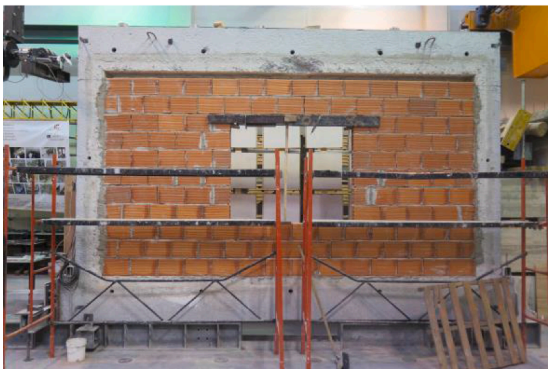
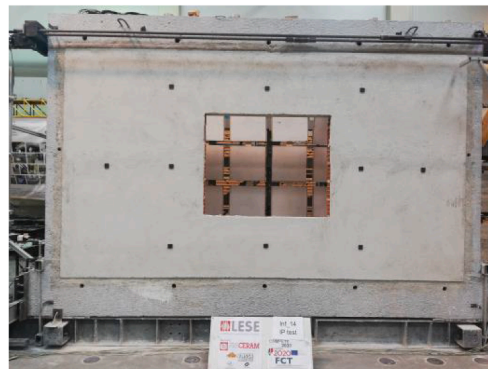
Fig. 3. Construction process of the openings: (a) step 1; (b) step 2; (c) step 3; (d) detail of the RC lintel reinforcement; (e) step 4 and (f) step 5.

No reinforcement was used to connect the infill panels and the surrounding RC frame, and no gaps were adopted between the panels and the frame. All the panels were built aligned with the outer side of the RC beam. The openings construction process was in agreement with the traditional techniques, which means that it was constructed an RC lintel in the top boundary of the openings. The lintel's geometric dimensions

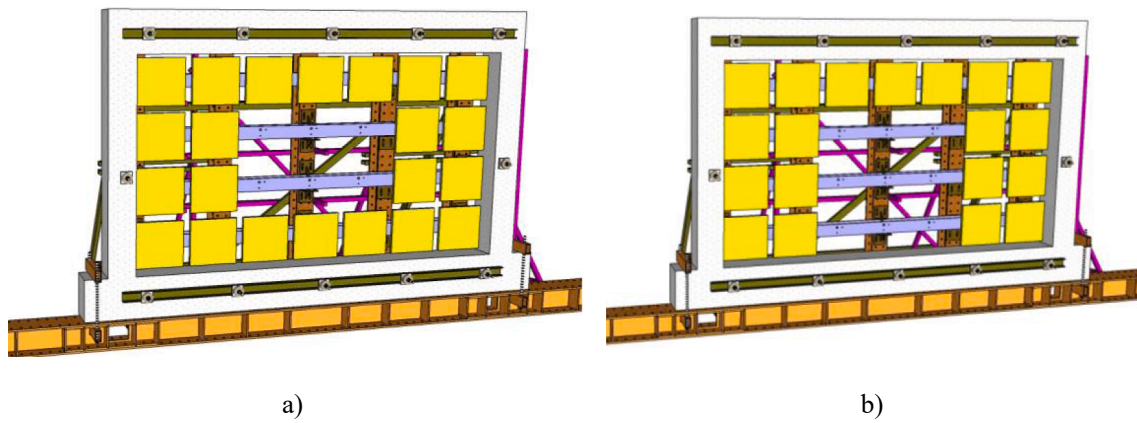
Fig. 4. Layout of the OOP test setup using pneumatic actuators: (a) for specimens Inf_14_CW_IPOOP and Inf_15_CW_OOP; and (b) for specimen Inf_16_CD_OOP.

The OOP test of all the specimens consisted in the application of a distributed OOP loading through several pneumatic actuators that mobilized the entire infill panel surface with wood plates (50 × 50 cm²) (one per actuator) placed between the actuators and the panel, as shown in Fig. 4a and b. Between the infill wall's surface and the wood panel, a 7 mm cork plate was included to help applying the load in a distributed manner avoiding stress concentrations. All the pneumatic actuators are linked to four horizontal steel elements, which react against five vertical steel elements. The horizontal steel elements are coupled with hinged devices that allow lateral sliding. The steel reaction structure is attached to the RC frame in twelve points (5 in the bottom beam, 5 in the top beam, and 2 in middle-height columns) with steel bars that are coupled with load cells to allow monitoring the OOP loadings. This self-equilibrated system balances the transmission of the OOP loadings to the reaction frame.

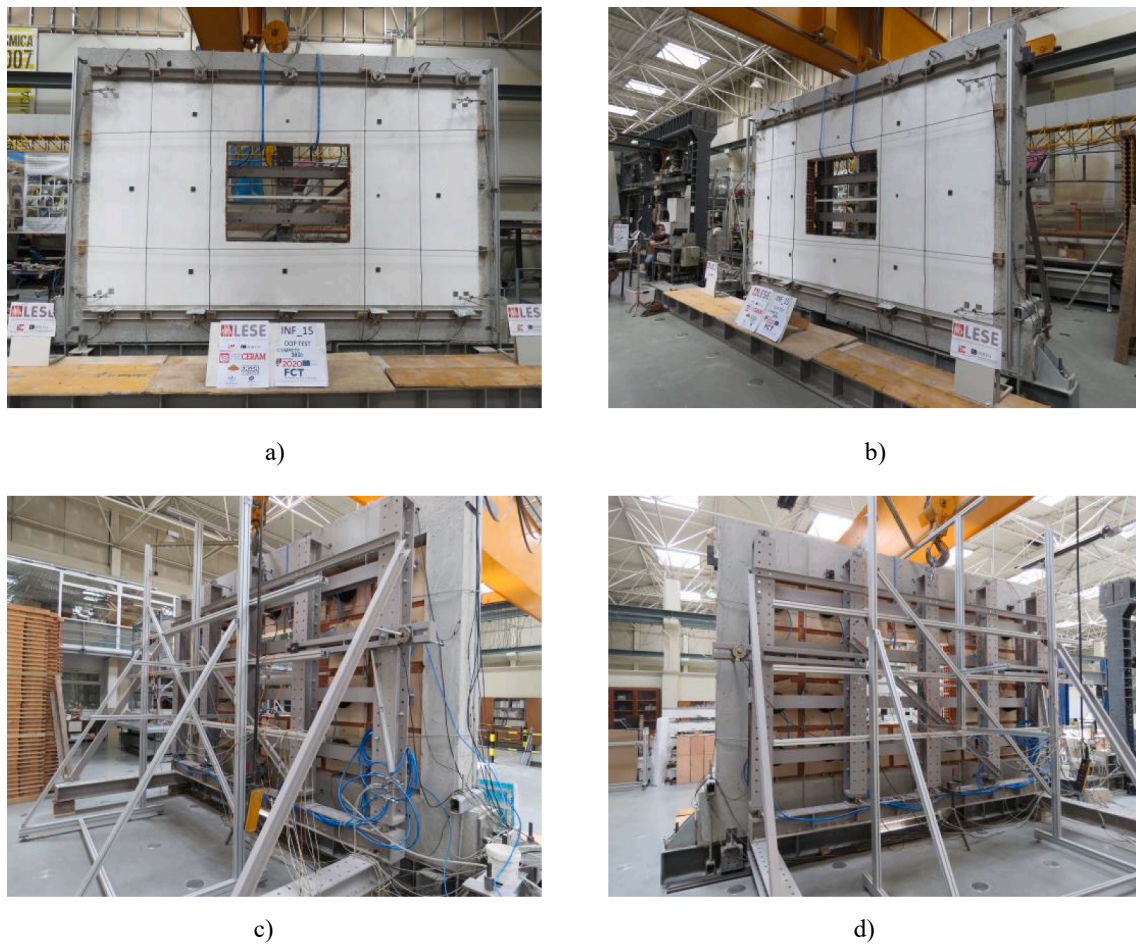
Fig. 5. General view of the OOP test setup for specimen Inf_15_CW_OOP: (a) Front view; (b) lateral view; (c) lateral back view and (d) backside view.

This load application approach is innovative in the literature since it can apply uniform OOP loadings in MIW with openings, due to the possibility of removing some of the pneumatic actuators according to the MIW configuration and dimensions. For example, Fig. 4c shows the test setup view used for the specimens Inf_14_CW_IPOOP and Inf_15_CW_OOP, in which six pneumatic actuators located in the centre of the panel (location of the opening) were removed. Due to the geometry of the specimen Inf_16_CD_OOP, nine pneumatic actuators were removed for the OOP test, as shown in Fig. 4d. The general view of the test setup adopted for the specimen with central window (Inf_14_CW_IPOOP and Inf_15_CW_OOP) and central door (Inf_16_CD_OOP) is shown in Figs. 5 and 6, respectively. The OOP tests

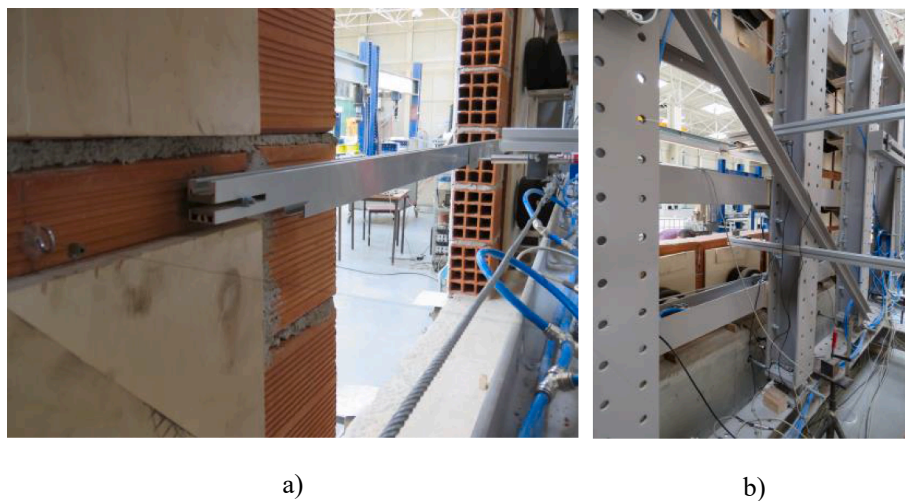
Fig. 7. Measurement of the control point: (a) detail of the tube steel profile; and (b) lateral view.

displacement in the selected point. It was established the same reference central point that was previously used for the panels Inf_08 (no opening, no previous IP damage) and Inf_11 (no openings, previous IP drift of 0.3%) to have the possibility of a direct comparison between specimens. Since the selected point is located in the opening area, the strategy adopted to measure the displacement consisted of using a steel tube profile fixed in the opening's two lateral extremities, as shown in, as shown in Fig. 7. The tube profile was cut, along the longitudinal direction, around the connector, which linked it to the panel surface. A stiff tube was selected, preventing the bending development and ensuring

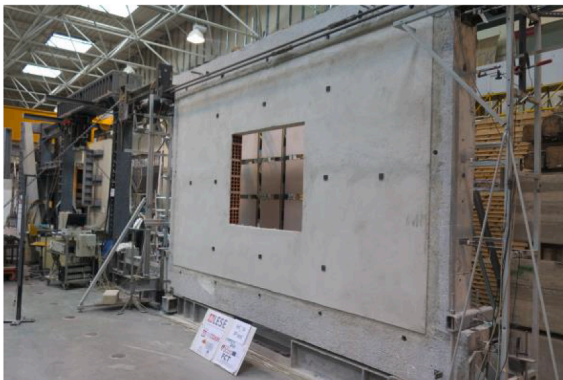
Fig. 8. View of the IP test setup: (a) Schematic layout; (b) Front view. (Instrumentation: schematic front layout (a) specimens Inf_14_CW_IPOOP and Inf_15_CW_OOP; (b) specimen Inf_16_CD_OOP.)

The quasi-static IP cyclic test consisted of applying a horizontal force at half the height of the RC frame's upper beam through a hydraulic

actuator with a capacity of approximately 500 kN and ± 150 mm travel. The hydraulic actuator is connected to a steel reaction structure. The horizontal force transmission to ensure full-cycle tests were performed using two steel profiles positioned on the top beam's extremities linked together through four dywidag bars ($\phi 27$ mm) prestressed, resulting in a beam compression of about 170 kN. The quasi-static cyclic test scheme

Several linear variable displacement transducers (LVDT’s) were used to measure the panel’s OOP displacements along five horizontal and vertical alignments (twenty-five in the case of the specimens Inf_14_CW_IPOOP and Inf_15_CW_OOP, and twenty-three in the case of Inf_16_CD_OOP). The wall detachment from the surrounding corners was measured by LVDT’s placed in the infill plane-frame interface. Six displacement transducers monitored the OOP displacements of columns and beams. Additionally, the top beam’s vertical displacements were measured by one LVDT placed at mid-span to monitor the evolution of possible arching mechanism. The displacement transducer “BV” placed in the top of the beam was used to measure the vertical beam displacement throughout the OOP tests. The schematic layout of the instrumentation used for each specimen is shown in Fig. 8.

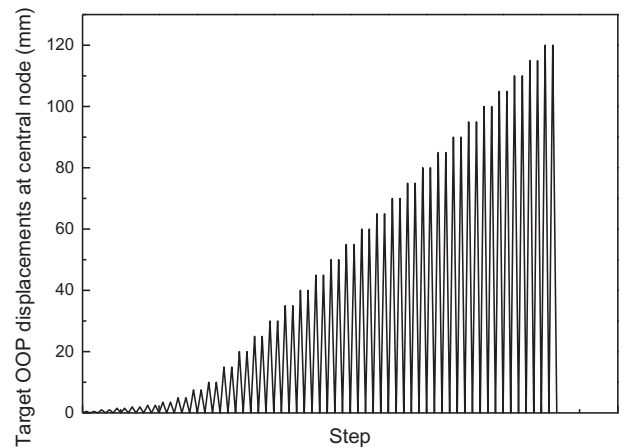
Fig. 10. Displacement history used in the OOP tests. (Specimen Inf_14_CW_IPOOP – OOP test: (a) Cracking pattern before the collapse; (b)–(e) collapse mechanism sequence and (f) Collapsed parts of the panel.)

The loading protocol is based on the protocol used in the previous tests [29] and consisted of the application of several half-cyclic OOP displacements (loading–unloading–reloading) that were imposed with steadily increasing displacement levels, targeting the following nominal peak displacements at the control node located in the centre of the panel (sensor W13): 0.5, 1, 1.5, 2, 2.5, 3.5; 5; 7.5; 10 mm; and then 5 by 5 mm up to a maximum OOP displacement of 120 mm (largest capacity of the

pneumatic actuators). Two half-cycles were repeated for each lateral deformation demand level. No axial load was applied in the top of the adjacent RC columns. The displacement history is presented in Fig. 10.
