Article

Characterisation of the progression of salts in walls of earthen architecture heritage

Keywords: earthen architecture, adobe masonry, mirabilite, thénardite, sodium sulfate

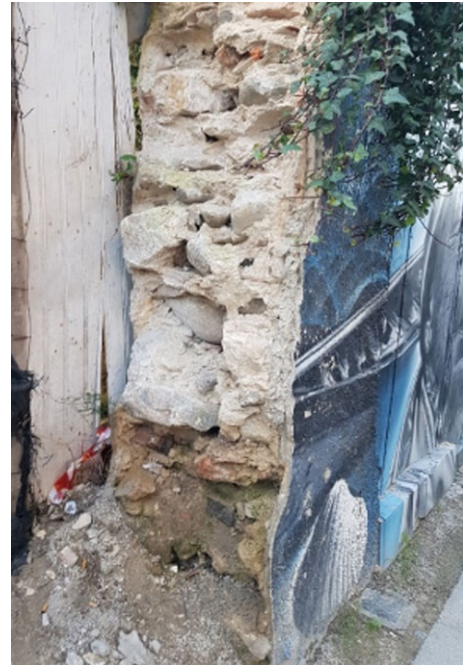
Fig. 2. Section of formed masonry with lime mortar, width of wall 0.52 m (© Alice Tavares).

In this region, building walls are formed masonry with lime mortar (Fig. 2), usually over a stone masonry wall with earthen filling. This wall can contain several materials: rocks of different compositions, shapes and sizes; bricks; tiles; and timber – creating a wall similar to a rammed earth wall. Adobe masonry is composed of adobe blocks and earthen mortar, both with lime in their composition (Fig. 3). Their shallow foundations (0.30 m to 0.50 m deep) present the same diversity of materials but with much more rock debris with larger dimensions, sometimes the same as those used as ballast in ships. The foundation (footing)

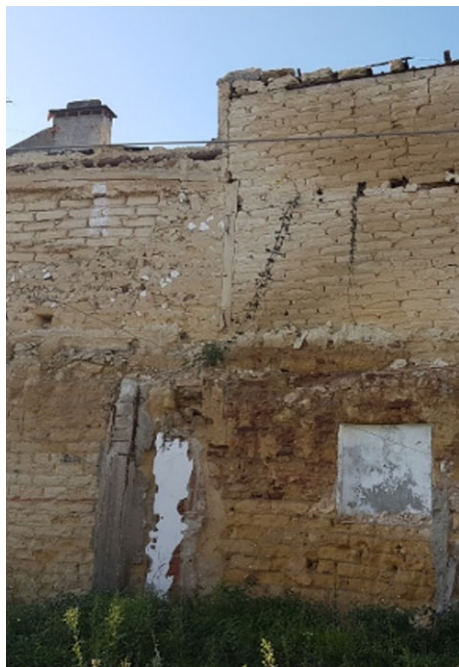
Fig. 3. Traditional wall of adobe masonry (© Alice Tavares).

of adobe walls can also be made with the same material (adobe) with a different layout of adobe blocks to thicken the wall and may also have solid bricks around the windows. The reduced depth of the foundation is a problem in terms of wall strength and in relation to control of rising damp, as the ground soil is composed mostly of clays with a high phreatic level.

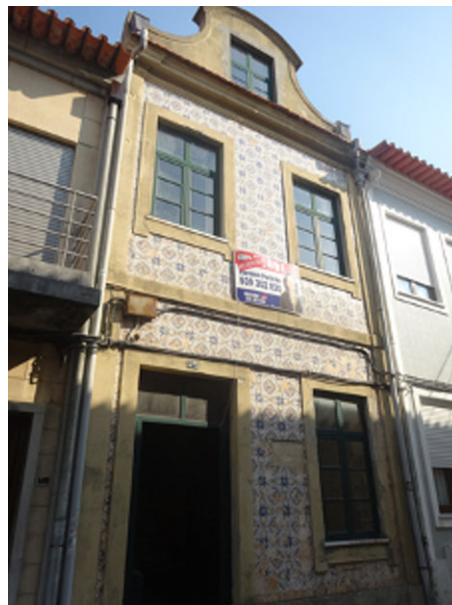
Fig. 4. Front façade of case-study building (© Alice Tavares).

A century-old earthen building in Aveiro was chosen for the case study, shortly before its rehabilitation. The building with two floors and an attic (Fig. 4) is 30 m from a channel of the *Ria de Aveiro* (Fig. 1b). The construction system of the building comprises loadbearing walls of formed masonry and adobe masonry with timber structures for the floors and roof. Two parallel walls with different constitutions – a formed wall (left in Fig. 5) and an adobe wall (right in Fig. 5) – from the room close to

The two walls were not plastered, the plaster was removed prior to this study in a preliminary stage of rehabilitation, however the formed wall had a first layer of plaster with mortar and pieces of broken tiles to fill gaps and increase the strength of this sublayer. There are openings in the adjacent wall (main façade wall), with a window on the side nearest the formed wall and an aluminium door with an opaque bottom (Figs 4 and 5) on the side nearest the adobe wall.

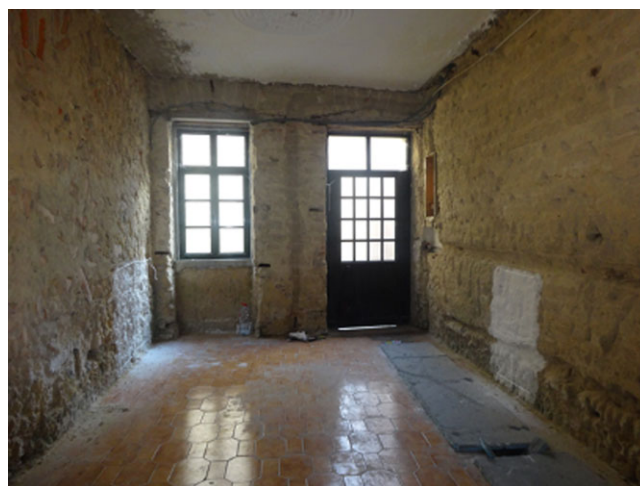
Fig. 5. Room of case-study building with lime water painting in two walls, left – formed wall; right – adobe wall (© Alice Tavares).

front façade were chosen for *in situ* tests. Both walls are loadbearing gable walls of the main room facing the street (Fig. 5) and have an approximate thickness of 0.35 m. They have a height of 3.20 m and support the timber beams of the upper floor structure. Both walls have 0.30 m deep foundations. The formed wall foundation has the same type of masonry as described above and the adobe wall foundation is made up of adobe blocks. Although both earthen walls present different constitutions, both are subjected to the same environmental conditions and water pressure with the same phreatic level. The floor of this room was cemented and covered with glazed ceramic tiles. The front facade wall is composed of adobe masonry and for this reason has a role in the interior hygrothermal conditions, contributing to diminishing thermal amplitudes inside (in the case study room).

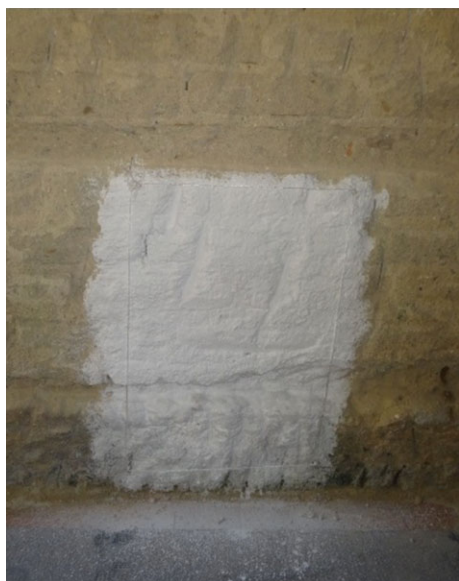
Fig. 7 - Colour online, Colour in print

Fig. 7. General view of the beginning of the lime water application (1.0 × 1.10 m) on adobe wall (© Alice Tavares).

Prior to the lime water application, selected areas of both test walls were scraped and surface salts removed. After cleaning the wall, brushing and removing salt, lime water was applied to both walls of the room in an area 0.5 m wide by 1 m high (Figs 6 and 7).

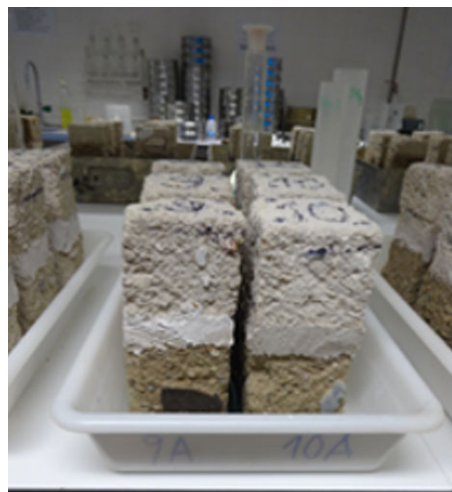
Fig. 8. Adobe combined blocks (18 × 8 × 8 cm) under capillarity test (© Alice Tavares).

In the laboratory, the adobe combined blocks (adobe block + mortar + adobe block) (Fig. 8) were made from two 8 cm edge adobe cubes glued together by a 2 cm thick mortar of dolomitic aerial lime + sand (a slurry of calcium dihydroxide and water [$w_{\text{water}} = m_{\text{water}}/m_{\text{total}} = 0.56$] was added to a mixture of sand and diatomite to which was added more water [$w_{\text{water}} = m_{\text{water}}/m_{\text{mixture}} = 0.20$]). The cubes were numbered, weighed and each edge measured. Each adobe combined block was identified and numbered with a code (CADn1, CADn2, etc.). They were kept for 60 days in a conditioning chamber with constant temperature ($\theta = 20^\circ\text{C}$) and relative humidity ($\text{RH} = 100 p_w/p_w^\circ = 95$, where p_w is the water vapour pressure above the salt solution, and p_w° is the saturation vapour pressure of pure water, at the measured

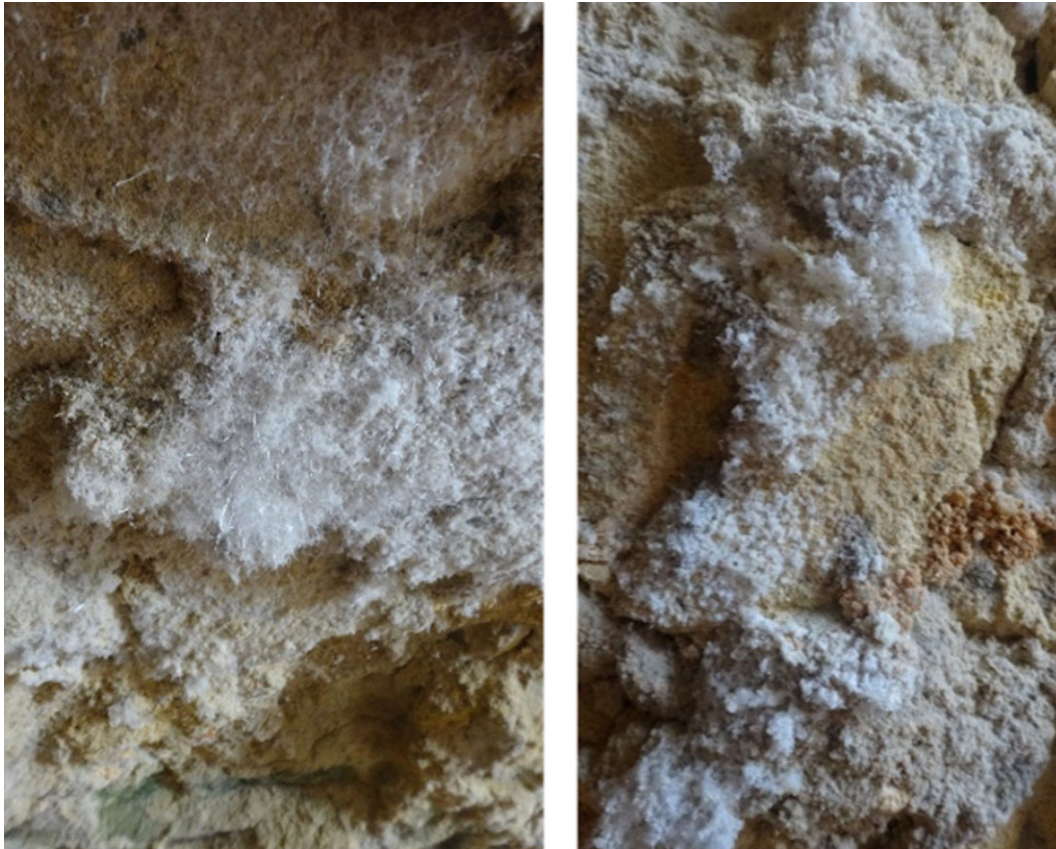
Fig. 10 - Colour online, Colour in print

Fig. 10. Presence of efflorescent salts in different locations on the formed wall, image height match: left - 6 cm; right - 36 cm (© Alice Tavares).

This first analysis based on visual inspection of the formed masonry wall (Fig. 10) recorded that the base of the wall was damp up to a height of 0.40–0.50 m, salt crystals could be observed in a dispersed form and up to ~1.00 m and the surface showed disaggregation. Above 0.50 m salt crystals in surface voids were visible, as well as a wider granular breakdown.

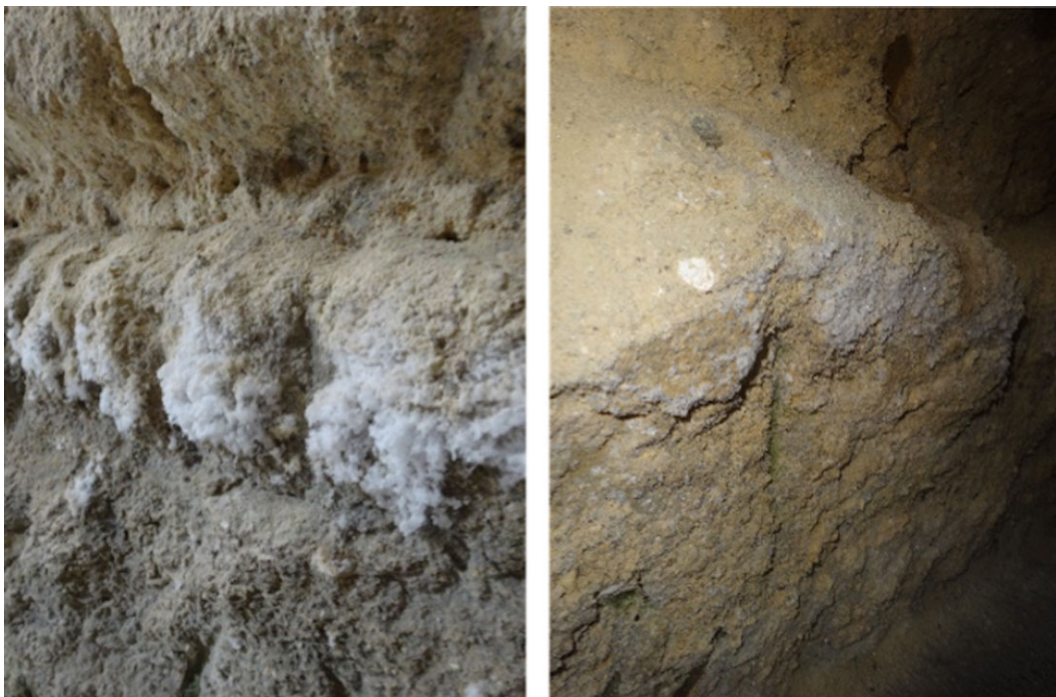
Fig. 11 - Colour online, Colour in print

Fig. 11. Presence of efflorescent salts in different locations of the same row of the adobe wall, image height match: left - 45 cm; right - 50 cm (© Alice Tavares).

The visual inspection of the adobe masonry wall (Fig. 11) found the base of the wall was damp and had a groove in the wall 0.30 m from the floor that had salt crystals on the lower border of the groove. It presented disaggregation on the inner and lower face of the groove. Above the groove there were few dispersed salts, although the granular disintegration of the wall reached ~1.10 m in height.

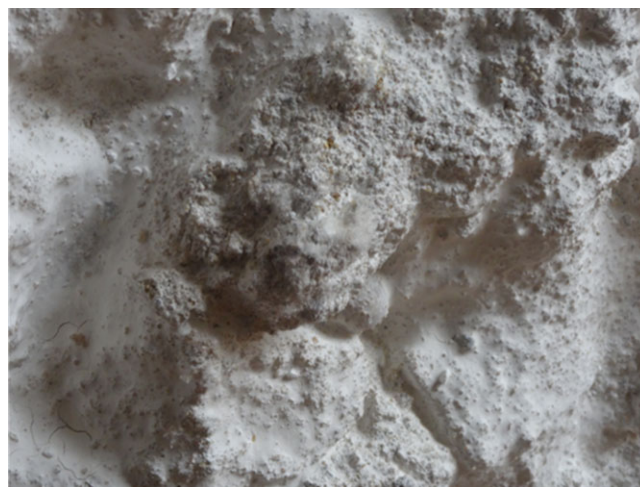
Fig. 12. Detail of salts and disaggregation in test area (image height match – 20 cm) of formed wall after seven days lime water painting (© Alice Tavares).

The first sampling of efflorescence and observation of the walls were carried out seven days after painting the walls with lime water. They showed that the presence of salts in the formed wall was still barely perceptible, by direct observation. Salts could only be seen in more prominent areas, though of reduced size, and some disaggregation was observed with loss of lime water paint (Fig. 12). On the contrary, on the adobe wall salts formed at its base (Fig. 13), especially on the lower edge of the groove, with greater expression than before the application of lime water. Apparently, the upper part of the adobe wall groove had no visible salts or surface disintegration; they were concentrated in the lower part of the wall’s groove. This occurrence may be associated with the fact that in the border area the nucleation is proceeds more easily, probably due to a higher concentration of the solution promoted by possible evaporation of water.

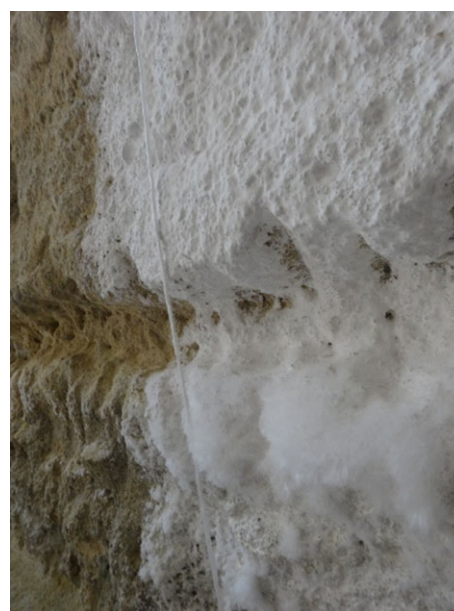
Fig. 13. Detail of salt efflorescences in test area (image height match – 50 cm) of adobe wall after seven days lime water painting (© Alice Tavares).

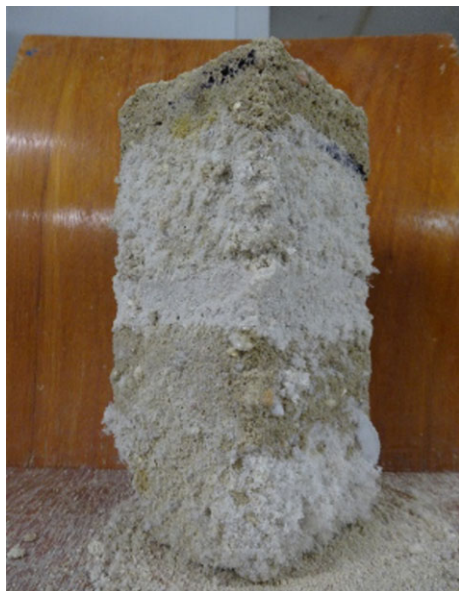
Fig. 14. Adobe combined block ($18 \times 8 \times 8 \text{ cm}$) after capillarity test with aqueous solution of sodium sulfate 1.15 mol kg^{-1} (© Alice Tavares).

During laboratory capillarity experiments with the aqueous solution of sodium sulfate, as can be seen from Fig. 14, the crystals started to grow immediately above the line of the aqueous solution ($\sim 1 \text{ cm}$ high). The sodium sulfate salts also crystallised on the mortar and adobe surfaces above the mortar. It was also observed that the adobe was starting to have small fragments coming off, both in the lower block above the level close to the aqueous solution line and in the block above the mortar. A semi-

quantitative analysis of the composition of the salts was not carried out, but the deleterious effect of the crystallisation of sodium sulfates in the adobes was clearly visible. Despite the crystallisation of salts on the surface of the mortar, there was no visible damage of its solid structure. Temperature and relative humidity during capillarity experiments were in the ranges of 17.9 to 18.5°C and of $100 p_w/p_w^\circ$ of 69 to 81, respectively. For this experimental temperature range, the deliquescence relative humidity of thénardite is ~ 86.4 for $100 p_w/p_w^\circ$, the deliquescence relative humidity of mirabilite is ~ 96 for $100 p_w/p_w^\circ$ and the equilibrium relative humidity for the mirabilite–thénardite transition is ~ 75 for $100 p_w/p_w^\circ$ (Steiger and Asmussen, 2008).

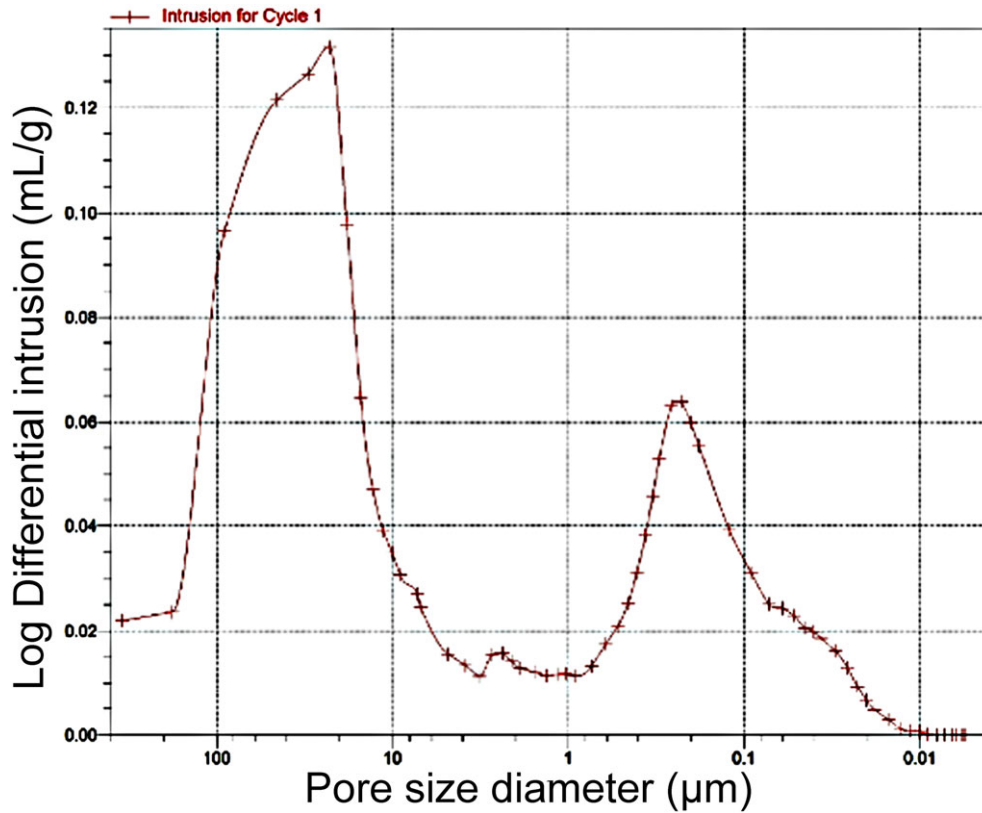
Fig. 15. Result of mercury intrusion porosimetry analysis of mortar sample before capillarity tests (© Alice Tavares).

The mortar used in this experiment, was chosen due to its porosity and capillary properties that predicted the possibility of sodium sulfate migration to its surface, decreasing the possible deleterious effect on the building material. As the *in situ* mortar

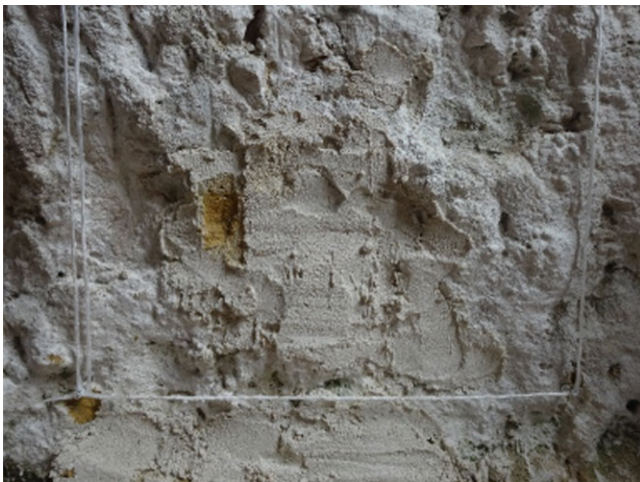
Fig. 16. Sacrificial mortar on formed wall. Sampling sites are the yellow areas, grid size – 50 × 40 cm (© Alice Tavares).

The mortar of air lime and sand with non-calcined diatomite was applied on a square area 30 cm wide, on both walls of the building studied (Figs 16 and 17). After cleaning the walls by brushing they were located in the same areas of the walls where the lime water paint was applied (Figs 6 and 7) and where larger amounts of salts crystallised in Step 2. Mortar samples from both walls were collected seven and ten days after its application and the collection sites are shown in Figs 16 and 17. Visual inspection of the mortar surfaces seven days after its application showed the absence of efflorescences, which was confirmed by XRD analysis of the mortar samples. However, the XRD pattern (Supplementary figs 7S and 8S) showed the presence of some calcium carbonate and

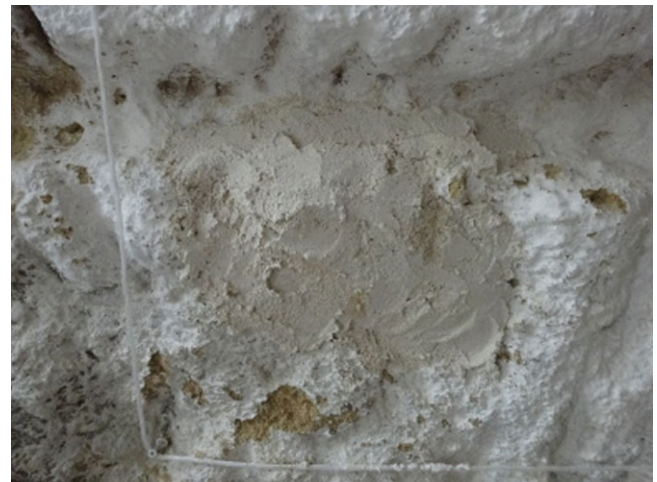
Fig. 17. Sacrificial mortar on adobe wall. Sampling sites are the yellow areas, grid size – 50 × 40 cm (© Alice Tavares).
