Non-destructive characterization of ancient clay brick walls by indirect ultrasonic measurements

To appear in: *Journal of Building Engineering*

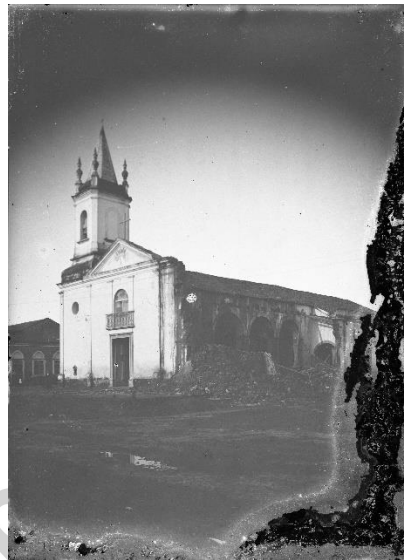
Figure 2. Partial collapse of the Nossa Senhora do Rosário dos Pretos Church, in 1974.

The Nossa Senhora do Rosário dos Pretos Church was built in 1775 by black man come from Africa, motivated by social and religious exclusion, and retrofitted on 1930. After that, in 1974 the church was affected by a flooding and part of the lateral north of the church collapsed (Figure 2). Only in 1982 the church was retrofitted and opened to public visitation. Today, the church is considered as one of the most relevant examples of black resistance and a symbol of the black fights against the discrimination in Brazil.

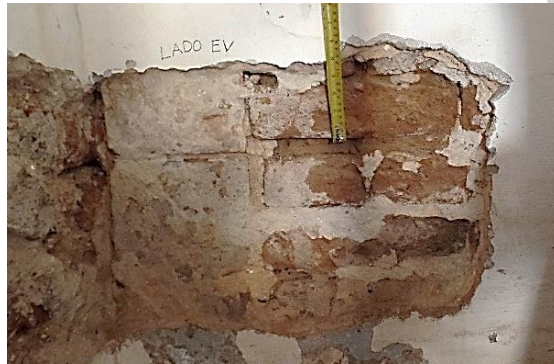
Figure 4. Detail of a clay brick masonry without mortar layer.

The main motivations for choosing Nossa Senhora do Rosário dos Pretos Church as case study, was the absence of structural records on the interventions performed on this building in the past, beyond it comprises an important heritage construction to Brazilian community. Moreover, in the final of 90s two reinforced concrete slabs were built in both lateral sides of the main nave, supported by the columns and the lateral walls of the church, as shown by Figure 3, and its long-time effect to structural safety of the church is not known, requesting regular assessment. Additionally, the clay brick masonries found in Brazil, especially in Northeast zone, are not extensively studied yet, and few cases on structural characteristic of this type of constructions can be found in the literature. The clay bricks of the Nossa Senhora do Rosário dos Pretos Church present an average dimension of 90x150x300mm and the detail of the clay brick masonry without mortar layer is presented through Figure 4.

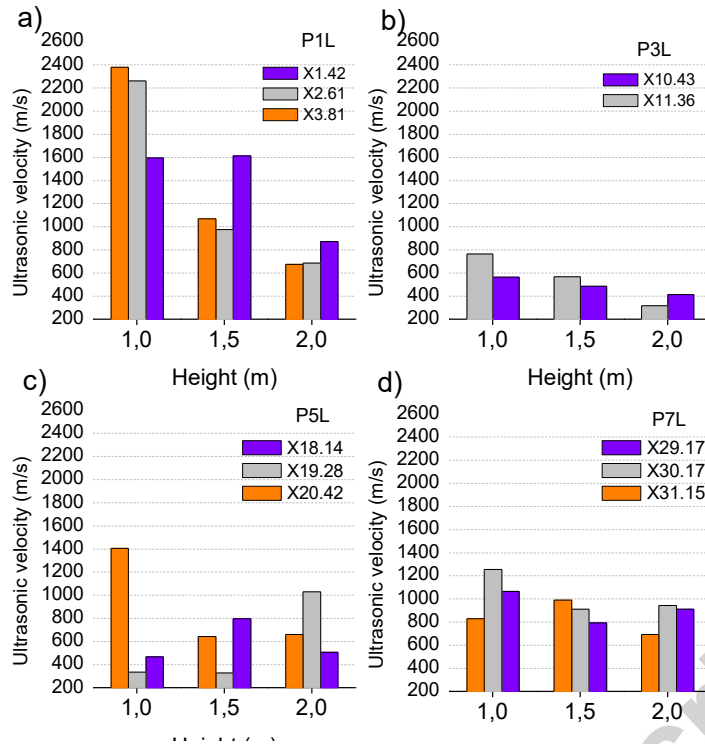
Figure 8. Height influence on ultrasonic velocities of the clay brick masonries P1L, P3L, P5L and P7L of the Nossa Senhora do Rosário dos Pretos Church.

Regarding the ultrasonic velocities, P1L (Figure 8.a) presented highest values than the others clay brick panels (Figure 8.b, c and d). The range of ultrasonic velocities observed in P1L vary between 2379.33 m/s, at 1.00 m of height, to 675.67 m/s, at 2.00 m of height. It was also observed that if the same height was considered, the measures of ultrasonic velocities present variation along of the X direction, in which the ultrasonic velocities collected in 1.00 m of height presented more dispersion than other two measures at another two height analyzed, namely at 1.50 m and 2.00 m. The average of the ultrasonic velocities measures performed at 1.00 m of height was of 1546.40 m/s, while the averages in the heights of 1.50 m and 2.00 m were 1219.93 m/s and 144.93 m/s, respectively. Taking into account the ultrasonic velocity average in

1.00 m as referential, the values of ultrasonic velocities in 1.50 m and 2.00 m presented an average decrease of 26.76% and 51.82%. Similar behavior of the ultrasonic velocities found in this work also were found in [18].

Considering the ultrasonic velocities collected by P3L testing (Figure 8.b), it was observed that the ultrasonic velocities averages (considering variations in X direction) also vary from 317.46 m/s to 564.51 m/s, corresponding to 1.00 m and 1.50 m of height of the measures performed on the panel. The ultrasonic velocity average was of 663.93 m/s to the height of 1.00 m, while for 1.50 m and 2.00 m of height the averages were of 526.85 m/s and 366.40 m/s, respectively. These values represent a decreasing in the ultrasonic velocities of 20.46% and 44.81% to 1.50 m and 2.00 m of height, considering the height 1.00m as reference. Similar behavior also was observed in P7L clay brick panel (Figure 8.d), in which the maximum value of ultrasonic velocity recorded was of 1254.48 m/s and the minimum was of 694.44 m/s, and the ultrasonic velocities average to 1.00 m, 1.50 m and 2.00 m were of 1049.82 m/s, 898.87 m/s and 850.07 m/s, respectively, corresponding to an average variation of the ultrasonic velocities of less 14.37% and 19.02%, considering the ultrasonic velocities measures at 1.00 m of height of the panel as referential.

Now, in relation with P5L results (Figure 8.c), it was observed that while the records of ultrasonic velocities at X distance of 20.42 m decrease for height variations, the values of ultrasonic velocities at X distance of 19.28 m increase for height variations between 1.00 m and 2.00 m. In addition, the ultrasonic velocities collected at X distance of 18.14 m, presented an increase of 467.28 m/s to 798.72 m/s between 1.00 m and 1.50 m, and a decreasing of 798.72 m/s to 508.68 m/s, between the heights of 1.50 m and 2.00 m. The ultrasonic velocities averages at the heights of 1.00 m, 1.50 m and 2.00 m were of 736.34 m/s, 590.99 m/s and 732.82 m/s, respectively. Considering the ultrasonic velocity average at 1.00 m as reference, in terms of percentage, the ultrasonic velocities vary in the order of 19.73% and 0.47% for 1.50 m and 2.00 m. In this case, the ultrasonic velocity behavior of the P5L clay brick panel can be explained taking into account the P5L position (see Figure 5), where a column possibly influences the ultrasonic velocities measured due to rearrangement of the compression and tension forces (in comparison with the other panels), provoking an inversion of the ultrasonic velocities behavior as the X position moves away from the column. In other words, changes in the ultrasonic velocities can also be related with variation from a zone with

less stiffness to a zone with greatest stiffness, in the case of the P5L panel from 20.42 m to 18.14 m along of the X direction.

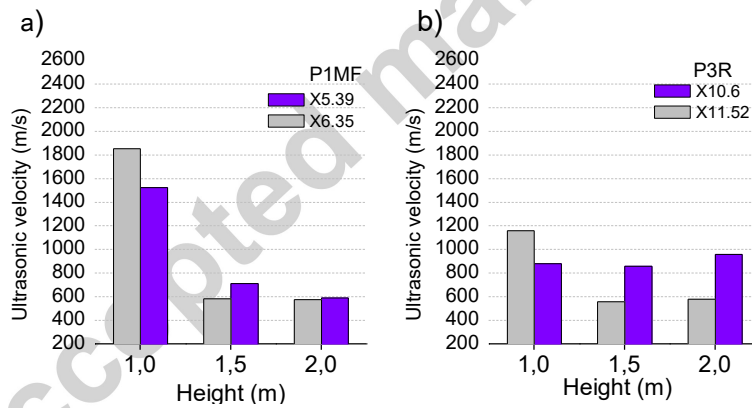
Figure 9. Influence of height on ultrasonic velocities of the clay brick masonries P1MF and P3R of the Nossa Senhora do Rosário dos Pretos Church.

Concerning the ultrasonic velocities results obtained by P1MF and P3R testing, shown by Figure 9.a and b, respectively, the ultrasonic velocities values vary from 576.69 m/s to 1853.22 m/s (to P1MF) and from 580.27 m/s to 1158.30 m/s (to P3R). The P1MF panel (Figure 9.a) presented an ultrasonic velocity average of 1688.40 m/s for height of 1.00 m, while for 1.50 m and 2.00 m the ultrasonic velocities averages obtained were of 647.98 m/s and 583.04 m/s. Considering the ultrasonic velocity average at 1.00 m as referential, the average values found for height of the 1.50 m and 2.00 m represent a decreasing in the ultrasonic velocities by height variation of 61.62% and 65.46%. Now, in relation to P3R clay brick panel (see Figure 9.b), the ultrasonic velocities averages found at the heights of 1.00 m, 1.50 m and 2.00 m were of 1019.67 m/s, 708.90 m/s and 769.06 m/s. In terms of percentage, considering the ultrasonic velocity measured at 1.00 of height as reference, the ultrasonic velocities values decreased 30.47% (for 1.50 m of height) and 24.57 % (for 2.00 of height). Complementarily, it is possible to note a lower dispersion between the ultrasonic velocities found by P3R testing, really different than the others analyzed clay brick panels. This different behavior can be related with the fact that this wall was rebuilt around 1982 and, this way, presents different constructive methodology and clay bricks with different characteristic (perhaps with mechanical properties improved) than the clay bricks used in the original walls.

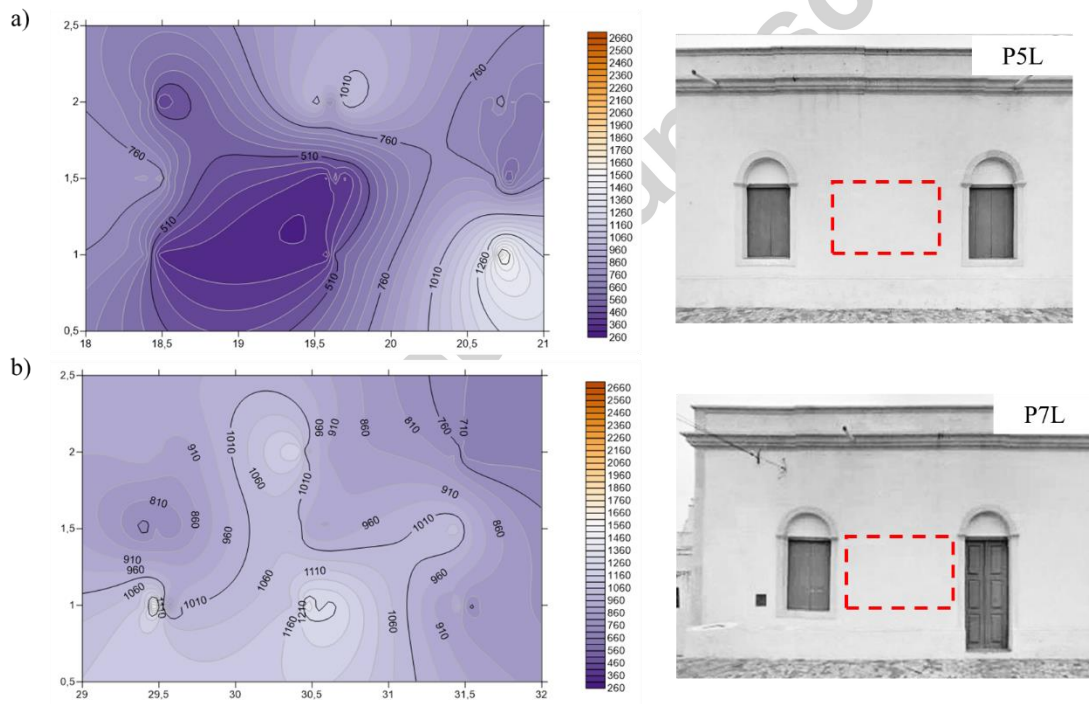
Figure 11. Ultrasonic velocities (m/s) distribution on the sections P3L and P7L.

From the analysis of the ultrasonic velocities distribution on the section P5L, shown by Figure 11.a, low ultrasonic velocities, aver around 600 m/s, were found between 18.5 m and 19.5 m of the X axes, characterizing the heterogeneity of this section in comparison with the others, while the analysis of the section P7L (Figure 11.b) shows homogeneity in the ultrasonic velocities distribution. After removal of the recovering layer (Figure 4) of the PL5 section, it was observed that the (irregular) distribution of the massive bricks in the region between 18.5 m and 19.5 m of the X axes was different than the other analyzed sections, with regular distribution of the massive bricks.

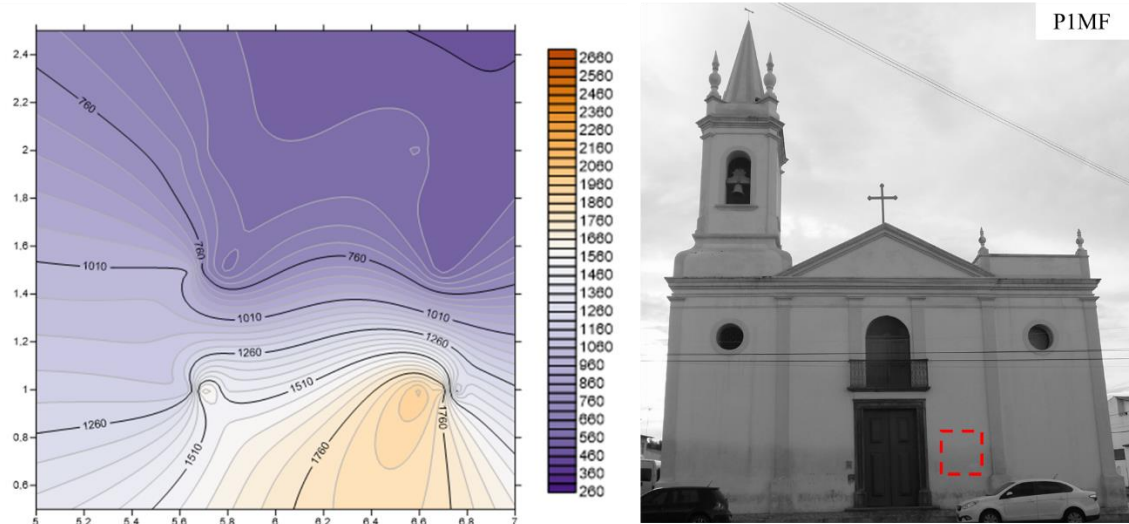
Figure 12. Ultrasonic velocities (m/s) distribution on the sections P1MF.

The analysis of the P1MF section (Figure 12), in the main façade, demonstrates similar behavior than the found in the P1L analysis, the high values of ultrasonic velocities found in the bottom of this section can also be related with the compression loading. It can be also noted that, since the main façade wall presents 1.40 m of high, the ultrasonic velocities tend to stabilize around 1100 m/s. In the south façade, the wall section P3R mapping is presented by Figure 13, where the ultrasonic velocities present a homogeneity distribution, aver around 900 m/s, with low dispersion between the record values. The P3R panel is located in the wall built around 1982, after the partial collapse of the church. This way, a most homogenous ultrasonic velocity behavior in this wall section can be related with employment of modern clay-bricks and cement composites, as well with the employment of a different methodology for masonry construction than the employed in the other walls.

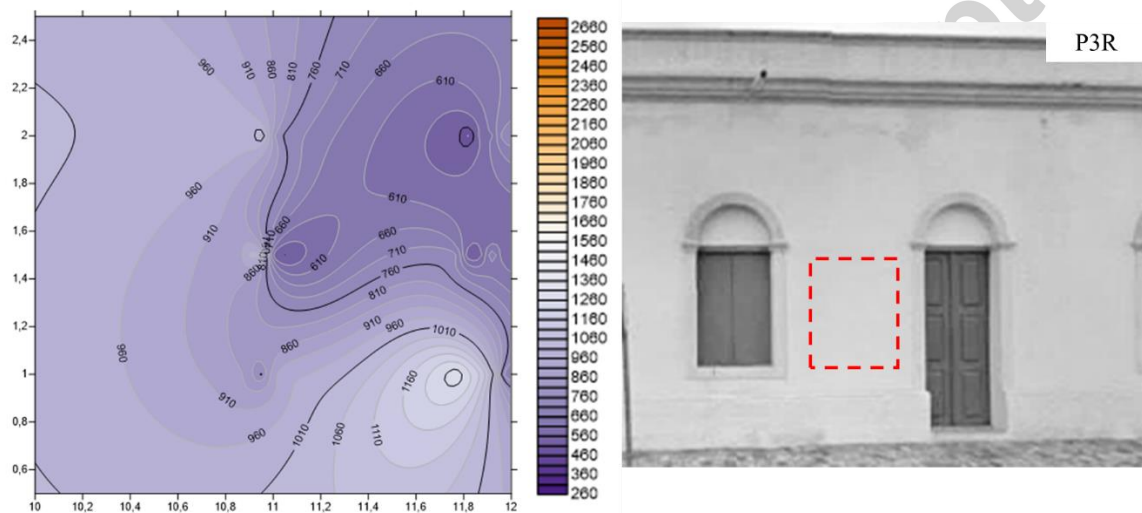
Figure 13. Ultrasonic velocities (m/s) distribution on the sections P3R.
