CHARACTERIZATION OF ADOBE BLOCKS FROM BURGOS

Theme 2: Heritage and Conservation

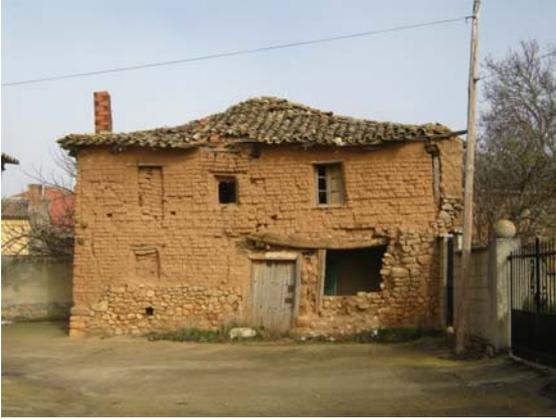
Figure 1 - House in Villasandino from which samples were extracted

In the rural area of Villasandino, Burgos, adobe was sampled from a residential, unoccupied house (Figures 1 and 2) and from a wine cellar. The house was built in adobe and wood but the inferior part of external walls was built in stone, thus keeping capillary water from damaging the earthen materials. The wine cellar was also built using adobe blocks, but it was partially excavated, leading to an underground storeroom with an excavated ceiling. In both cases, the building suffered from degradation, enabling sampling of adobes.

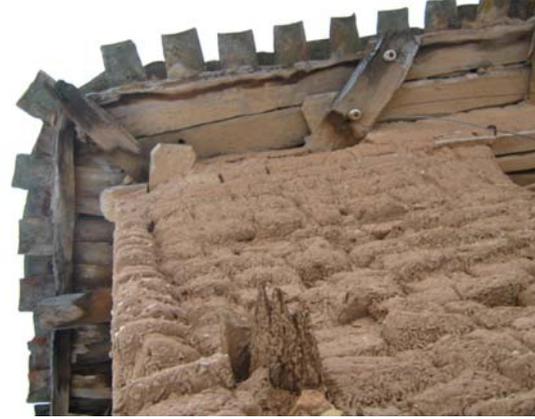
Figure 2 – Detail of house in Villasandino from which samples were extracted
