Seismic vulnerability assessment of masonry facade walls

T. Ferreira, R. Vicente & H. Varum
University of Aveiro, Portugal

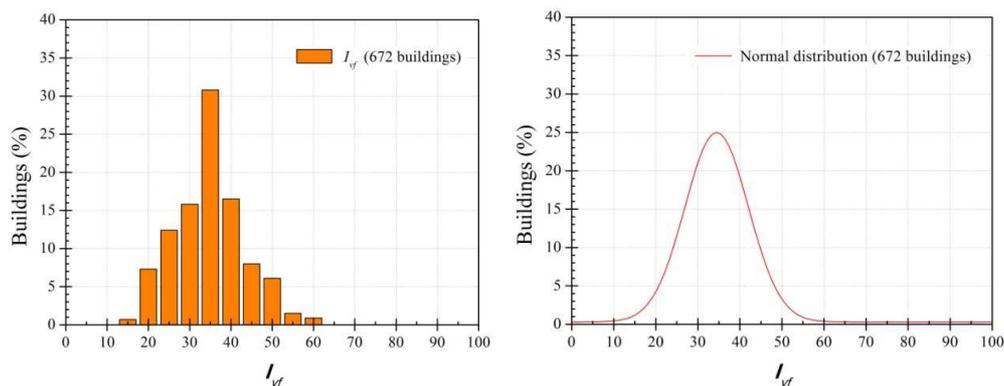
Fig. 2.1 shows the distribution of the vulnerability index calculated for the 672 buildings assessed (detailed and non-detailed approaches), as well as the best-fit normal distribution.

Figure 2.1. Vulnerability index distributions: histogram and best-fit normal distribution

The mean value of the seismic vulnerability index ($I_{vf, mean}=37.08$) obtained for the facade walls, indicates that these structural systems of the traditional limestone load bearing masonry buildings of the historical city centre of Coimbra is relatively high. About 33% of the evaluated facade walls presented a seismic vulnerability index above 40, while about 16.5% presented a value higher than 45. The maximum and minimum values obtained for I_{vf} , for all the buildings assessed was 64.09 and 11.36 respectively.

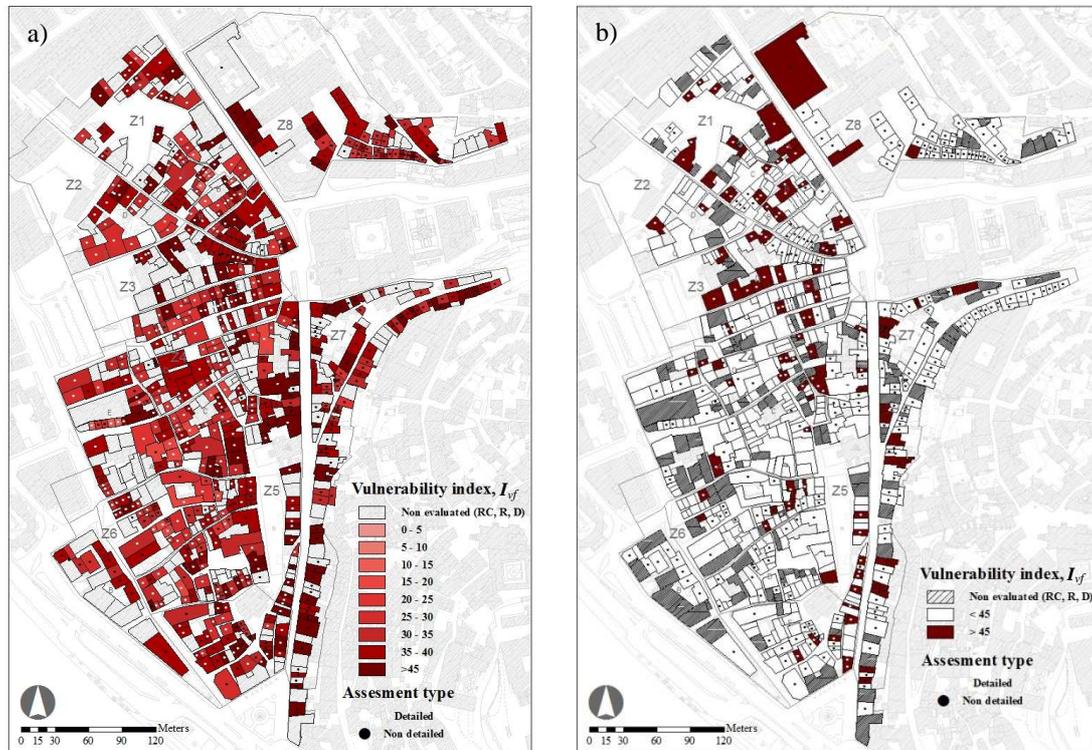
In the GIS platform, specific commands were programmed to allow an easy access to all the information, as well as for the implementation of the damage and loss estimation algorithms (mathematical and probability functions). Fig. 2.2 presents the seismic vulnerability index distribution for all the facade walls evaluated. Through the overall analysis of Fig. 2.2, it is possible to identify the critical buildings, as well as the urban areas where an expressive concentration of building facades with high seismic vulnerability index.

Figure 2.2. Vulnerability mapping of the facade buildings: a) Global vulnerability index distribution; b) Identification of the buildings with $I_{vf} > 45$

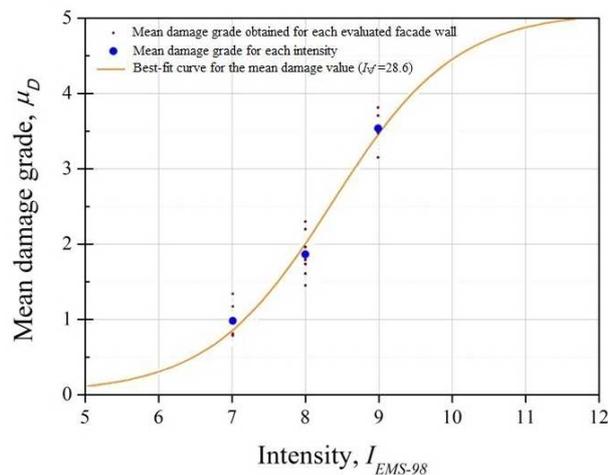
Associating the mean damage vulnerability index obtained for each group of facades ($I_{vf}=28.6$) with the different damage grades for each of the three seismic intensities and with the buildings assessed (VII, VIII and IX), it was possible to obtain a first approximation of the vulnerability curve which correlates the macroseismic intensity, I_{EMS-98} , with the mean damage grade, μ_D . Fig. 3.1 presents the approximation obtained for the mean vulnerability index value, $I_{vf}=28.6$, through an adjusted third degree polynomial curve.

Figure 3.1. Best-fit curve for the mean damage grade

The three values for mean damage grade were obtained through the average of the values resulting from the vulnerability index method application for all the facade walls, for intensities VI, VII and VIII, while the remaining two values were defined in correspondence to mean damage grade 0 (no damage) and 5 (total collapse), to give a start and an end point to the function.

Adjusting the curve presented in Fig. 3.1 for facade walls, to the analytical function given by Eqn. 3.1, it was possible to obtain a new semi-empirical expression for the mean damage grade estimation for facade walls. Eqn. 3.3 arises from several adjustments and calibrations, based on intensity/damage observation of facade walls affected by Abruzzo earthquake.

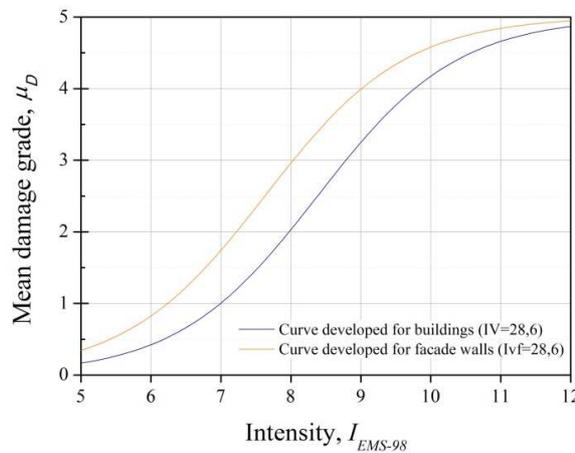
Fig. 3.2 presents the confrontation between both vulnerability curves, developed for buildings, and facade walls, given for the mean vulnerability index value of 28.6. Based on recent seismic events, it is possible to state that masonry facade walls, when compared to buildings themselves, and for the same seismic intensity, tend to present more extensive damage. Thus, this typical difference in damage justifies the gap between both vulnerability curves plotted in Fig. 3.2.

Figure 3.2. Confrontation between vulnerability curves for buildings and facade walls ($I_{vf}=28.6$)

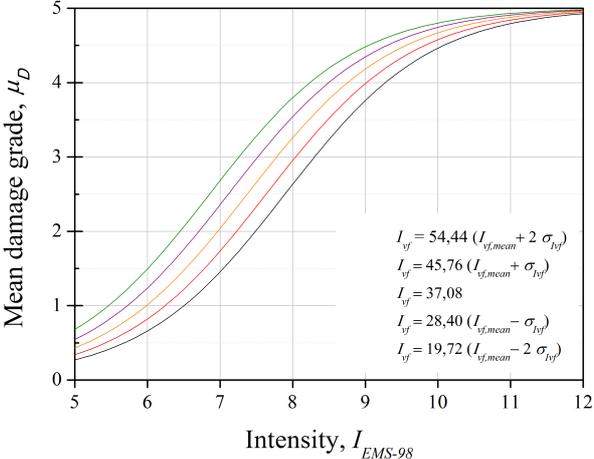
In Fig. 3.3 are shown the seismic vulnerability curves (in the I_{EMS-98} versus μ_D format), obtained with Eqn. 3.3, for the average value of the vulnerability index estimated for all the masonry facades of the traditional buildings of the old city centre of Coimbra ($I_{vf,mean}=37.08$). Also, in the same figure are plotted upper and lower bound ranges ($I_{vf,mean} - 2\sigma_{Ivf}$; $I_{vf,mean} - \sigma_{Ivf}$; $I_{vf,mean}$; $I_{vf,mean} + \sigma_{Ivf}$; $I_{vf,mean} + 2\sigma_{Ivf}$) obtained for the 672 assessed masonry facade walls (standard deviation, $\sigma_{Ivf}=8.68$).

Figure 3.3. Vulnerability curves for the facade walls of the historical city centre of Coimbra

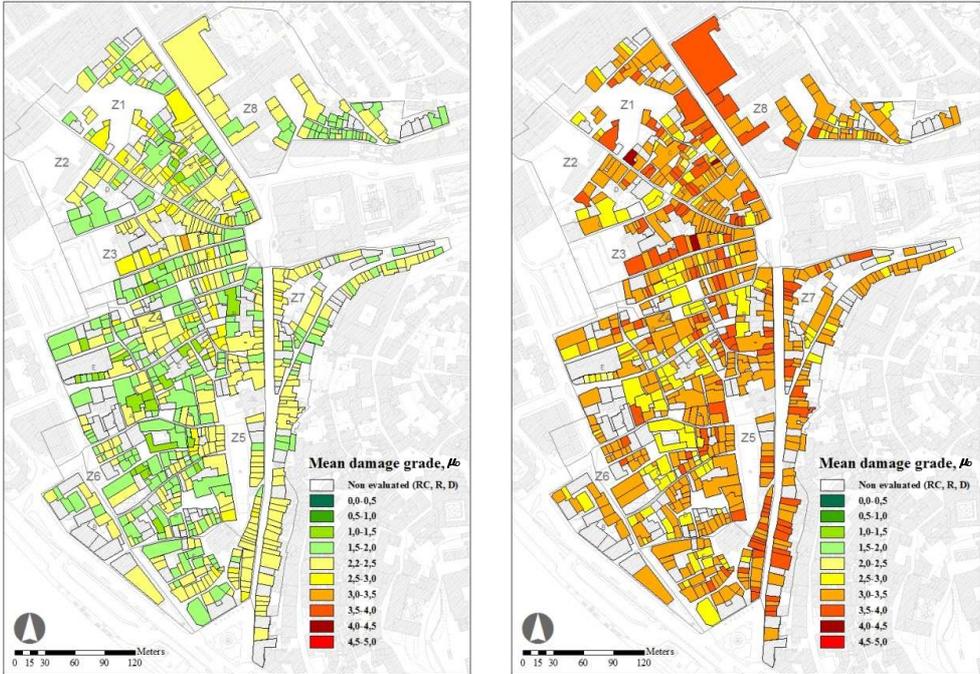
Using GIS, loss scenarios for the whole area under study can be developed and evaluated, for each building facade. Fig. 3.4 presents the damage scenarios obtained for seismic intensities of VII and VIII. These two seismic scenarios correspond to the maximum felt earthquake event in the district of Coimbra (1755 historical event). The building facades damage estimation ranges from 1.21 to 3.03 for an earthquake scenario with $I_{EMS-98}=VII$, and from 2.32 to 4.04 for $I_{EMS-98}=VIII$. The mapping of mean damage grade, μ_D , resorting to the GIS tool, facilitates the risk analysis, identifying areas of higher vulnerability and consequently with higher potential risk of damage. Moreover, it allows to prepare and plan post-event strategies, such as rescue and safety planning [see Ferreira, 2009]

Figure 3.4. Building facade damage distribution for $I_{EMS-98}=VII$ and $I_{EMS-98}=VIII$

From the analysis of Fig. 3.4, for a scenario of seismic intensity of VIII, it is estimated that the majority of the assessed masonry facade walls present a mean damage grade, μ_D , of about 3. This indicates, for the earthquake intensity VIII scenario, that the majority of building facades would suffer severe damages ($3 \leq \mu_D < 4$) and a relevant number would be in a situation of imminent collapse.
