Structural Behaviour Assessment and Material Characterization of Traditional Adobe Constructions

Authors Humberto Varum*, Aníbal Costa, **Dora Silveira**,
Henrique Pereira, João Almeida, Tiago Martins
Address Civil Engineering Department, University of Aveiro,
Campus Universitário de Santiago, 3810-193 Aveiro,
Portugal
E-Mail * hvarum@civil.ua.pt

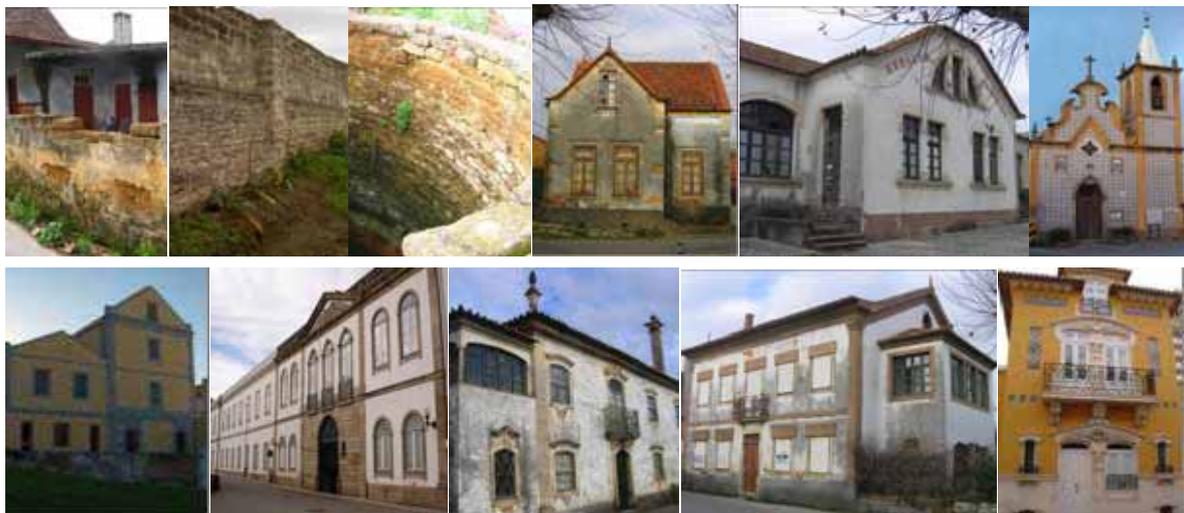
Figure 1. Examples of existing adobe constructions in Aveiro district.

the delimitation of properties, water wells, churches and warehouses (Fig. 1). An important number of the urban adobe buildings are of cultural, historical and architectonic recognized value, namely of the “Art Nouveau” style. The old Aveiro fire station building, the church of Quintãs, and the old flour-mill building recently converted by the University of Aveiro into a space for science results diffusion, among many others, are just good examples of existing adobe buildings in Aveiro district with important socio-cultural value. A more detailed description of the predominant constructive typologies can be found in (3).

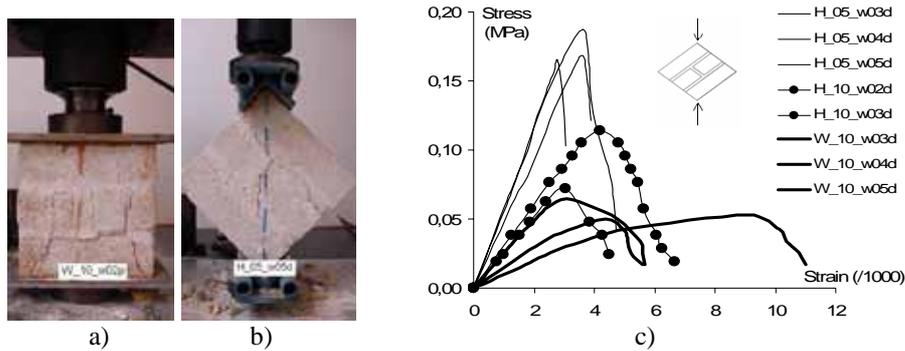
Figure 2. Compression test on wallet, a) perpendicular and b) diagonal to the bed joints. c) Stress vs strain relation obtained in diagonal to the bed joints compression tests on small wallets.

To estimate the compressive and shear strength of adobe traditional masonry walls, 13 small wallets with 17×17×10cm were constructed and submitted to compression tests, perpendicular to the bed joints and diagonally (Fig. 2). The wallets were constructed at a reduced scale (1:3). For the construction of the wallets, prismatic blocks were extracted from adobe units taken from existing constructions, and a mortar with a composition similar to the traditionally used was adopted.

The compressive and shear strength obtained from compression tests on wallets are between 0.77 and 1.57MPa; and between 0.05 and 0.19MPa, respectively. For the wallets constituted by adobe units with a lower compressive strength, lower shear and compressive strengths were obtained. Transversal modulus of elasticity and shear strength, for each series of tested wallets, are about 1/10 of the corresponding modulus of elasticity and compressive strength evaluated in compression tests perpendicular to the bed joints.

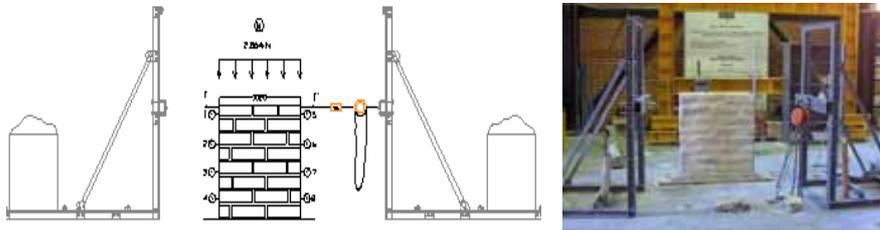
Figure 3. In-plane cyclic testing layout: wall specimen; reaction frames; horizontal displacement transducers; dynamometer; and horizontal loading system.

A constant vertical load of 2.86kN was applied on the top of the wall, to simulate the behaviour of a wall with double height, as commonly observed in existing constructions, and in-plane horizontal forces were imposed, in cycles of increasing amplitude, till the collapse was reached (Fig. 4). In Fig. 3 is presented a general scheme of the testing layout, including the wall specimen and the loading and displacement measuring systems.

For the cyclic tests it was not applied an additional vertical load. Initially, in-plane horizontal cyclic forces were imposed, in cycles of increasing amplitude (Fig. 5). The scheme of the testing layout is similar to the one adopted for the test in laboratory conditions (Fig. 3).

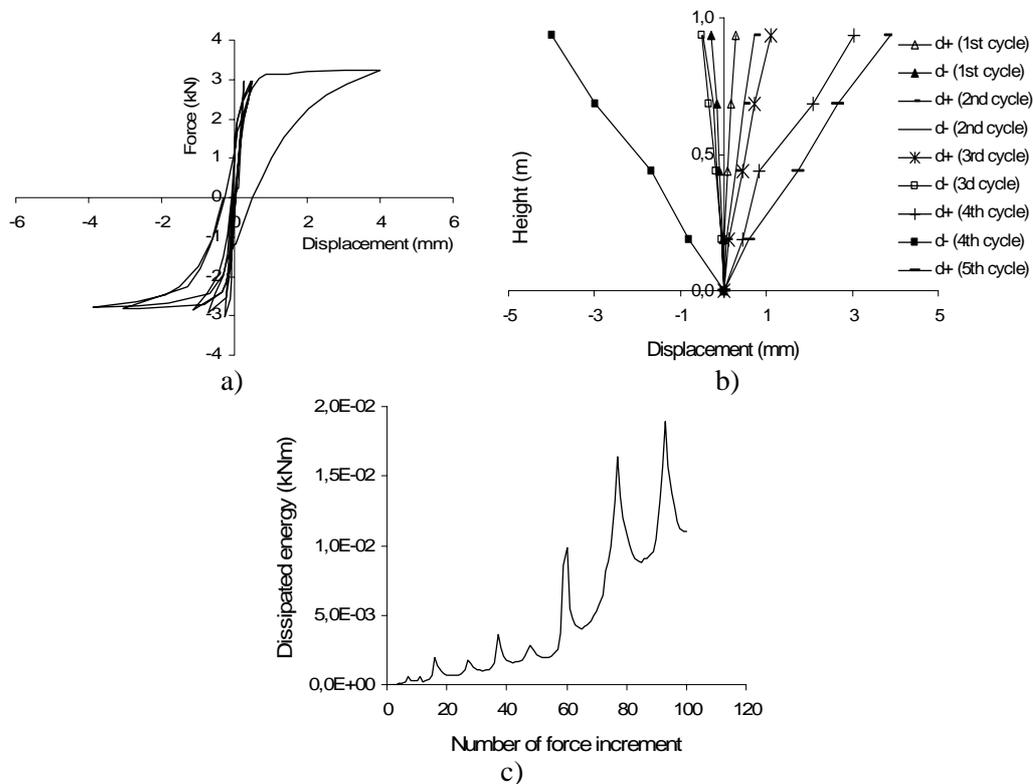
Figure 4. In-plane cyclic laboratory test results: a) applied horizontal force vs top-displacement; b) displacement profiles for peak horizontal forces; c) dissipated energy evolution.

A maximum horizontal force of 3.2kN was applied. The failure mode was traduced by the opening of a horizontal crack at the base of the wall. This observed failure mode corresponds to the typical response of this type of masonry walls for low vertical stress levels. The reduced value of the vertical stress in the wall induces a rigid body behaviour, when subjected to horizontal cyclic loads, which is traduced by a rotation of the wall, almost intact, over its inferior and superior edges (“rocking”).

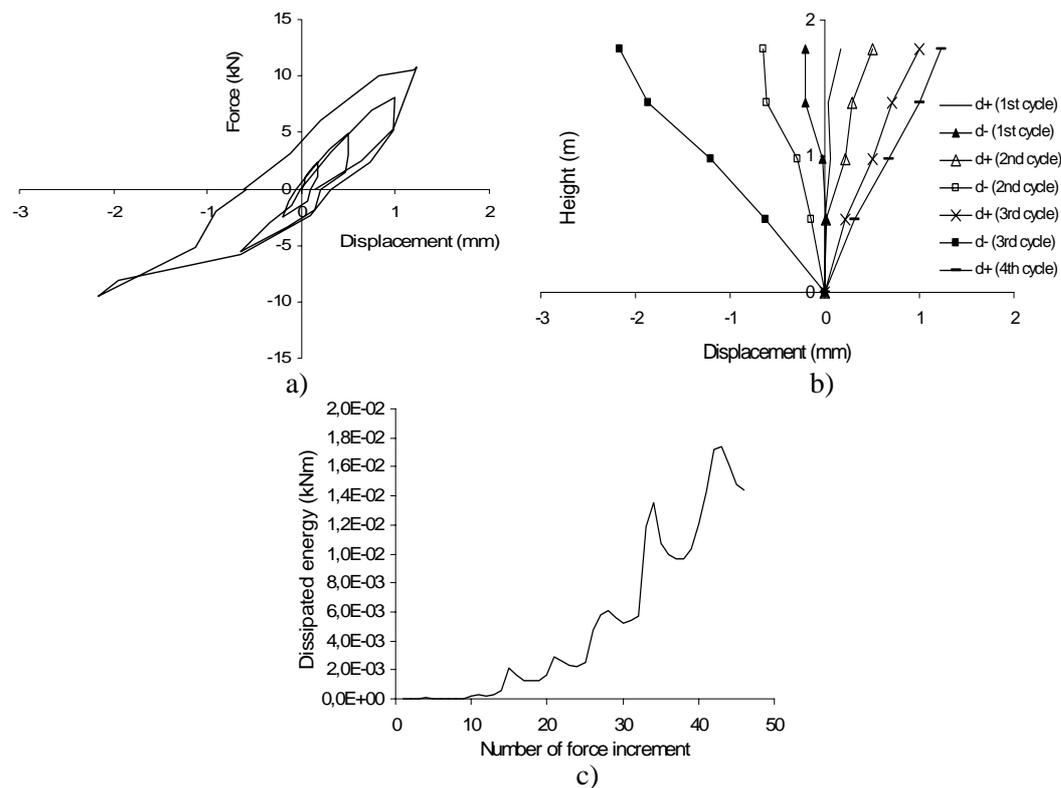
Figure 5. In-plane cyclic in-situ test results: a) applied horizontal force vs top-displacement; b) displacement profiles for peak horizontal forces; c) dissipated energy evolution.

A maximum horizontal force of 10.7kN was applied. This force was not raised to a higher level in order to allow performing the out-of-plane test.

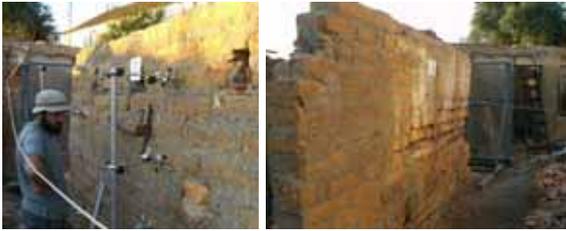
Figure 6. In situ out-of-plane cyclic testing layout: wall; horizontal displacement transducers; and horizontal loading system.

The wall tested *in-situ* conditions had the following dimensions: 2.03m height, 3.73m width and 0.22m thickness. It presented a significant deterioration level, as can be observed in Fig. 6. This

In a second phase, adopting a different testing setup (Fig. 6), out-of-plane horizontal forces were applied to the wall, in cycles of increasing amplitude, but without inversion of the force signal, till the collapse was reached (Fig. 7).

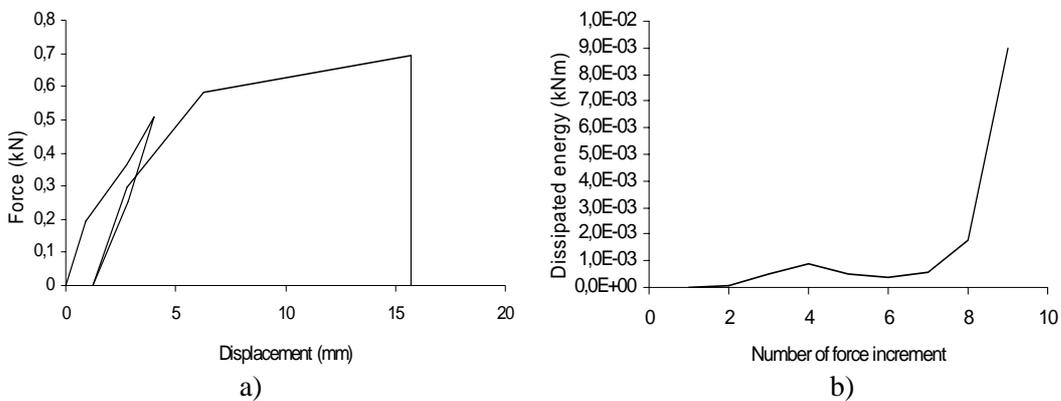
Figure 7. Out-of-plane cyclic in-situ test results: a) applied horizontal force vs top-displacement; b) dissipated energy evolution.

A maximum horizontal force of 0.69kN was applied in the out-of-plane direction. The out-of-plane collapse happened for an imposed horizontal displacement of 16mm (approximately 0.95% drift). For the in-plane test similar drift values were imposed for forces 15 times superior without collapse. This, and the fact that the out-of-plane wall strength is less than 7% of the corresponding in-plane strength, demonstrate that this type of adobe wall elements are significantly more vulnerable to out-of-plane actions. The failure mode observed is characterized by a rotation at the base, with damage spreaded through the wall height.

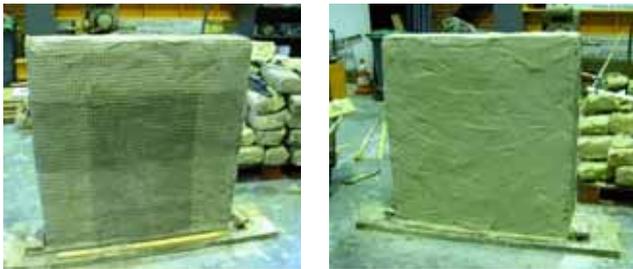
Figure 8. Strengthening of the wall with a wrapping polymeric mesh, and with plaster mortar.

In addition to the work that has been developed for the mechanical characterization of adobe masonry walls, it has also been initiated work on the study of adobe masonry strengthening solutions. The wall tested in laboratory, presented in section 2.5.1, was strengthened with a wrapping polymeric mesh and coated with a mortar layer with composition similar to the traditionally used in the existing constructions (Fig. 8). The structural response of the strengthened wall when subjected to imposed horizontal cyclic displacements is currently under investigation. The behaviour improvement achieved with the applied strengthening solution will then be evaluated. This analysis is just the first step of a larger work that aims to develop effective strengthening solutions for the existing adobe constructions.
