Study of the Structural Behaviour of Traditional Adobe Constructions

Humberto Varum, Aníbal Costa, Dora Silveira, Maria Fernandes

In Aveiro, Portugal, adobe can be found with abundance in rural and urban buildings. Many of these buildings present, however, an important level of structural damage. To face the lack of information concerning the mechanical properties and structural behaviour of adobe masonry, it was developed an experimental campaign at University of Aveiro. The mechanical behaviour of adobe units, mortars and small wallets was studied. Laboratory and *in situ* tests on full-scale walls were performed. Test results reveal the behaviour and structural fragilities of adobe elements, and will help in the assessment of existing constructions, and in the strengthening strategy definition.

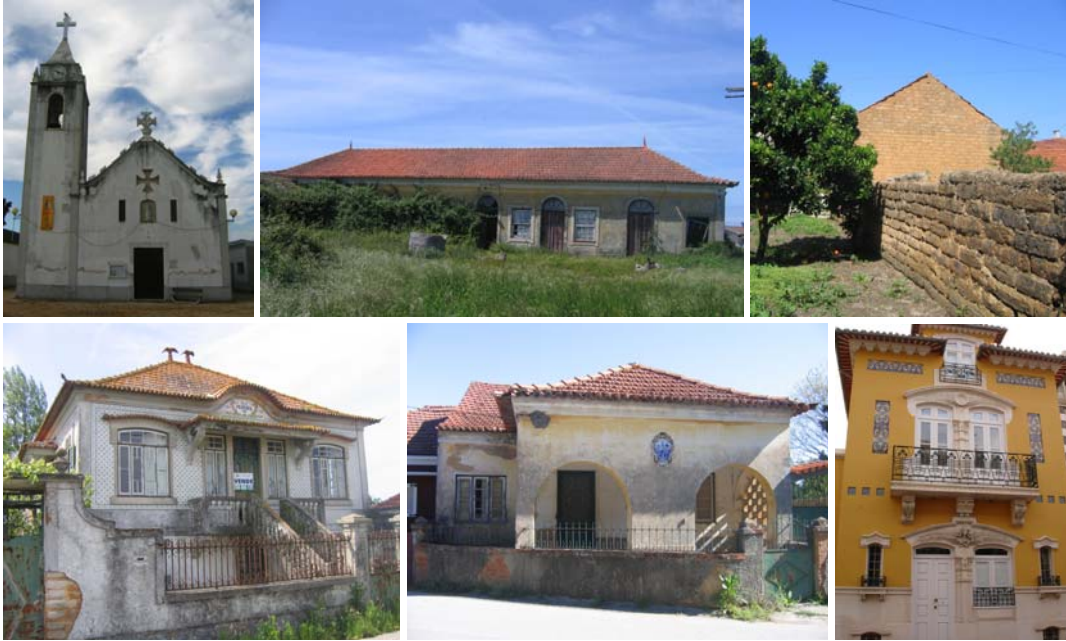
Varum Fig. 1

1. Examples of existing adobe constructions in Aveiro district. Photos: University of Aveiro.
2. Simple compression test (a), and splitting test (b) on adobe specimens. Compression test, perpendicular to the bed joints (c), and compression test, diagonal to the bed joints (d), on wallets. Photos: University of Aveiro.

In the near past, earth was a very common construction material in Portugal. Adobe and rammed earth were used through years in almost all types of construction, having this utilization declined during the first half of 20th century, with the emergence of cement industry. Rammed earth was more applied in south and adobe in littoral centre, especially in Aveiro district (Oliveira and Galhano 1992; SAT 1992). Presently, according to information from the municipality, about 25% of the existing buildings in Aveiro city are made of adobe. It is estimated that this percentage rises to 40% when referred to the entire district. Adobe can be found in varied types of construction: rural and urban buildings, many of which are still inhabited, walls for the delimitation of properties, water wells, churches and warehouses (fig. 1). An important number of the urban adobe buildings are of cultural, historical and architectural recognized value, belonging some of them to the “Art Nouveau” style. A more detailed description of the predominant constructive typologies can be found in (Varum et al. 2006a:41-45).

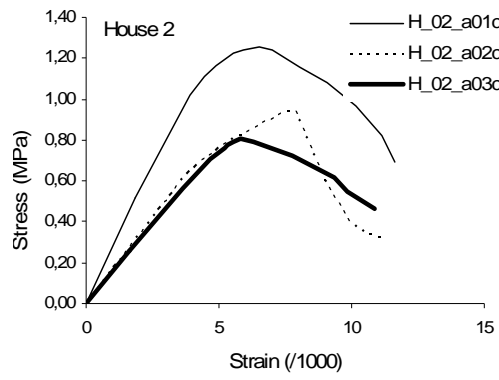
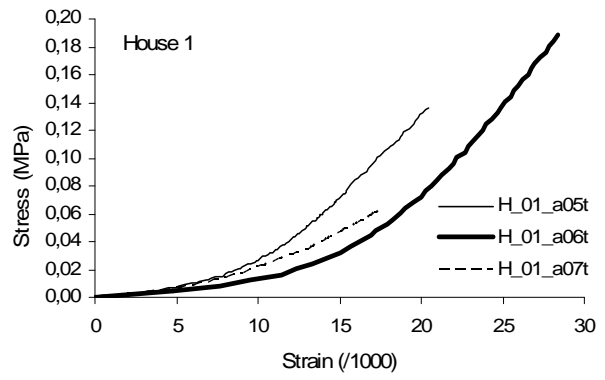
Varum Fig. 3

3. Stress vs strain relations obtained in simple compression and splitting tests. Graphs: University of Aveiro.
4. Stress vs strain relation obtained in compression tests on small wallets, diagonal, and perpendicular to the bed joints. Graphs: University of Aveiro.

A total of 101 cylindrical specimens, 51 proceeding from houses and 50 from land dividing walls, were submitted to mechanical tests: 83 specimens were submitted to compression; and 18 to splitting tests (fig. 2a, fig. 2b, fig. 3).

The adobe specimens present significant compressive strength values, varying from 0.32 to 2.46MPa. For each construction analysed, the tensile strength corresponds to approximately 20% of the compressive strength. Results for the analysed adobe samples reveal a clear tendency for samples with larger fractions of small dimension particles to present superior compressive and tensile strength values.

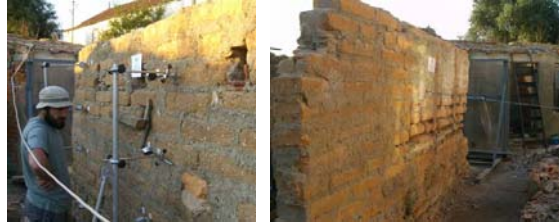
Varum Fig. 7

Figure 7. *In situ* out-of-plane testing layout: wall; horizontal displacement transducers; and horizontal loading system.

7. *In situ* out-of-plane testing layout: wall; horizontal displacement transducers; and horizontal loading system. Photos: University of Aveiro.
8. Strengthening of the wall with a wrapping polymeric mesh, and with plaster mortar. Photos: University of Aveiro.

The wall tested *in situ* was subjected to dynamic characterization tests, and to two horizontal cyclic mechanical tests, namely: an in-plane semi-destructive test and an out-of-plane destructive test (fig. 6, fig. 7).

horizontal force of 0.69kN was applied out-of-plane. The failure mode observed is characterized by a rotation at the base, with damage spread through the wall height.

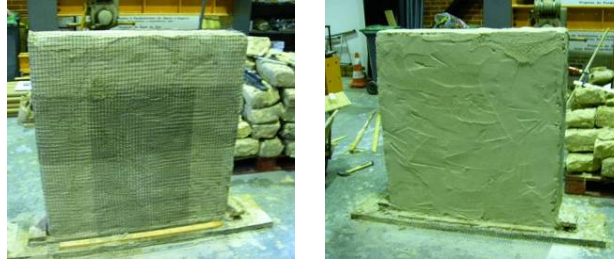
Varum Fig. 8

Figure 8. Strengthening of the wall with a wrapping polymeric mesh, and with plaster mortar.

The wall tested in laboratory, presented in section 2.5.1, was strengthened with a wrapping polymeric mesh and coated with a mortar layer with composition similar to the traditionally used in the existing constructions (fig. 8). The structural response of the strengthened wall when subjected to imposed horizontal cyclic displacements is currently under investigation. The behaviour improvement achieved with the applied strengthening solution will then be evaluated.
