Earthen Construction: Structural Vulnerabilities and Retrofit Solutions for Seismic Actions

ABSTRACT:

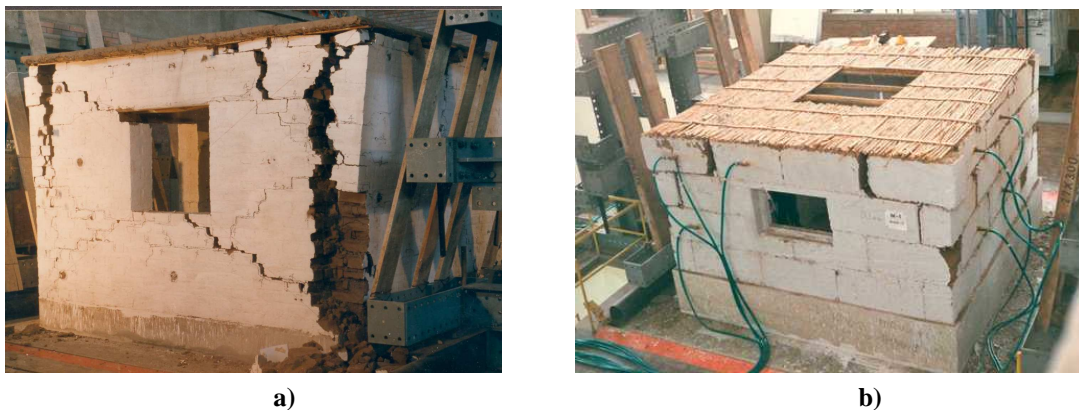
Figure 1 shows adobe and rammed earth models with no seismic reinforcement tested in PUCP facilities, on the shaking table. In the adobe model, it is possible to see vertical out-of-plane cracks in the corners, which correspond to the failure of the connections between walls, and in-plane diagonal cracks, relative to shear failure. The rammed earth model presents different crack patterns more concentrated next to the model corners.

Figure 1 – Experimental tests of unreinforced earthen models: a) adobe house, b) rammed earth house (credits: [Zegarra, L. et al.; 1997])

The failure of non-reinforced adobe structures due to seismic actions is a brittle failure. The small tensile resistance of the masonry causes the failure of the connection of the walls in the corners, starting in the upper part. This isolates the walls from each other and conducts to a loss of lateral stability, causing the collapse of the wall out of the plane. If the corners failure is controlled, than the walls can support horizontal seismic forces in its plane. The second type of failure that occurs is due to shearing force. In this case, the typical inclined cracks of diagonal traction appear.

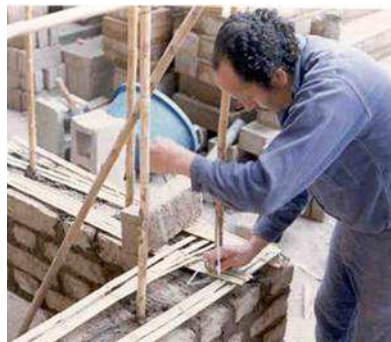
This type of reinforcement consists of placing an internal grid, with vertical and horizontal elements, able to bond efficiently with the structure, improving its seismic performance (see example in Figure 2). The vertical elements should be conveniently anchored to the foundation and to a collar beam on top of the walls. The spacing of the vertical or horizontal elements should be such to provide an efficient connection to the structure. [Blondet, M.; Aguillar, R.; 2007] provides design rules for these reinforcements. Bamboo canes or eucalypt dry timber is recommended for these reinforcements [SENCICO; 2000]. It should be noted that this type of reinforcement can only be done in new constructions.

Figure 2 - Internal cane mesh reinforcement (credits: [Vargas et al.; 2005])

However, the placement of the horizontal layers should be carefully carried out, as these can become weak points, which, under seismic forces, can cause horizontal cracks. In the case of rammed earth, it is difficult to compact the earth near the reinforcement, while for adobe structures, in order to provide an effective bonding, mortar thickness between two rows of adobe blocks, with reinforcement in between, can become larger than desirable [Minke, G.; 2001]. Laboratory tests proved that high thickness mortars correspond to less wall masonry strength.

Full-scale shaking table tests were conducted with adobe houses using this kind of reinforcement, demonstrating a good response to save lives [Blondet et al.; 1988]. The model reinforced with an internal cane mesh suffered significant damage, but did not collapse. A major restraint in using this strengthening solution is the fact that cane or adequate timber is not available in all seismic regions [Blondet, M.; Aguillar, R.; 2007].

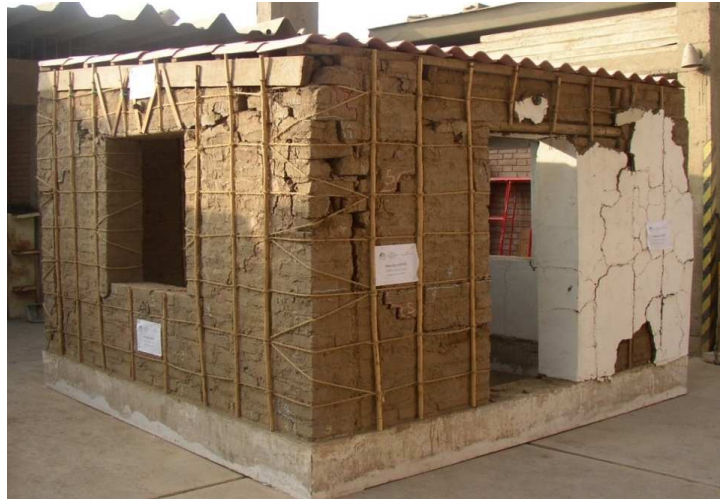
Figure 3 shows an example of this type of reinforcement applied to a real-scale model tested in PUCP, where only part of the structure was covered with plaster.

Figure 3 - External cane-rope mesh reinforcement (credits: [Torrealva y Acero et al.; 2005])

For repair or seismic retrofit of existing structures, an external reinforcement using a grid of canes and ropes can be a good solution. Canes are placed vertically and externally to the wall, on both sides, inside and outside. Ropes are then positioned horizontally tying the vertical canes along the walls and involving the structure. Different rows of horizontal ropes are placed along the height of the wall with a spacing of 30~40cm. In order to connect the two grids, outside and inside grids, and thus confine the

earthen structure, small extension lines are placed connecting the two grids, crossing the wall from one side to another through holes, made at each 30~40cm. This reinforcement grid can then be covered with plaster for adequate finishing, providing at the same time more confinement to the earth structure.

The main limitation of this type of reinforcement is the fact a great quantity of cane is required. As cane is not available in all regions, industrial material must be studied and tested.

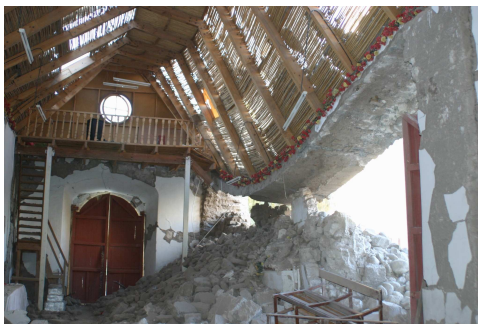
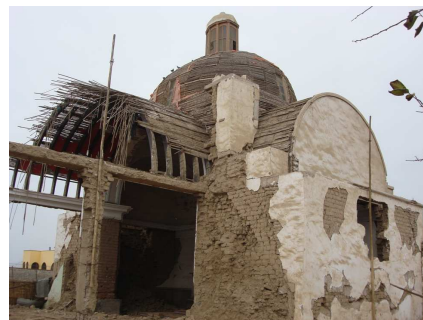
This technique consists of building first the adobe walls with gaps in the corners, or connections with other walls to be filled by concrete. Steel bars are then placed and the concrete is poured in order to form a confined system with columns and collar beam. This solution is rather expensive, conducting to a high stiffness system with low ductility [Minke, G; 2001]. Furthermore, important collapses in earthen construction with reinforced concrete elements were reported, implying that this can be an inadequate reinforcement solution, though more studies on the subject are required. Figure 4 shows examples of collapses after reinforcement using concrete: Tarapaca Cathedral, Iquique earthquake, 2005, Chile and San Luis de Cañete Church, Pisco earthquake, 2007, Peru. In Tarapaca Cathedral, the bending of the reinforced concrete beam destroyed completely the main adobe wall with 1.30m of thickness. In San Luis de Cañete Church, the frames of reinforced concrete changed the behaviour of the structure and unfilled adobe walls were overturned.

Figure 4 – Examples with collapses after reinforcement using concrete: a) Tarapaca Cathedral, Chile, 2005 [Chesta, J; 2005] b) San Luis de Cañete Church, Peru, 2007 (credits: [Vargas, J. et al.; 2007])
