Survey on the main defects in ancient buildings constructed mainly with natural raw materials

In this context an early 19th century Portuguese watermill building is used as a study case to show how a roof leaking may lead to a progressive building collapse.

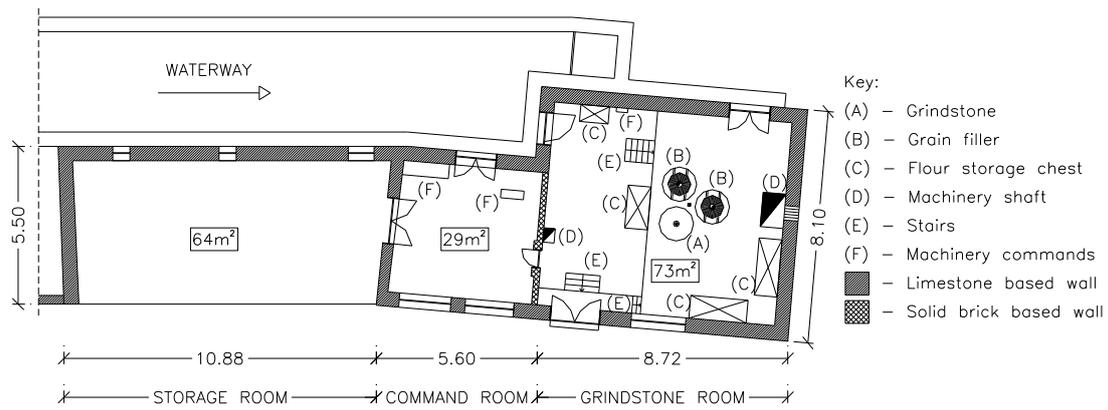
Figure 3. Ground floor Plant, 2009 (m)

The building has basically three rooms located in the ground floor. These rooms are the grindstone room, the machine command room and the storage room, Fig. 3. The grindstone room has a 73 m^2 area in which exist the grindstone, two grain fillers and massive wooden chests to retain the flour. The machine command room has a 29 m^2 area where the turbine's switching levers are located. Finally, the storage room has a 64 m^2 area and its purpose was for storing the grains and flour. Thus, the building has a total area of 166 m^2 .

According to Fig. 3 there are two types of walls. There are several limestone based masonries walls and one solid ceramic brick based wall. The function of the last one is partition. In contrast, the main ones have a structural function since they support the roof system.
