Post-earthquake damage classification and assessment: case study of the residential buildings after the $M_w = 5$ earthquake in Mila city, Northeast Algeria on August 7, 2020

Hamidatou Mouloud¹ · Amar Chaker² · Hallal Nassim¹ · Saad Lebdioui³ · Hugo Rodrigues⁴ · Matthew R. Agius⁵

Abstract

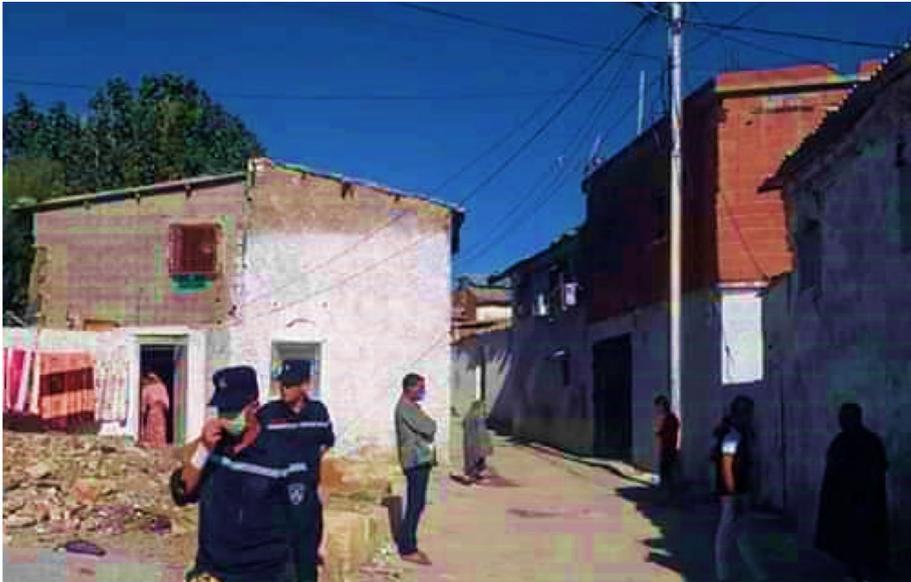
still exists today. These structures were either unaffected by the earthquake or suffered only minor non-structural damage. Newer buildings, on the other hand, tended to have more stories and less interstory height than older buildings, which clearly influenced the seismic response of neighboring structures (Fig. 8).

Fig. 8 Insertion of new concrete constructions "within" existing blocks during the building process and at the end

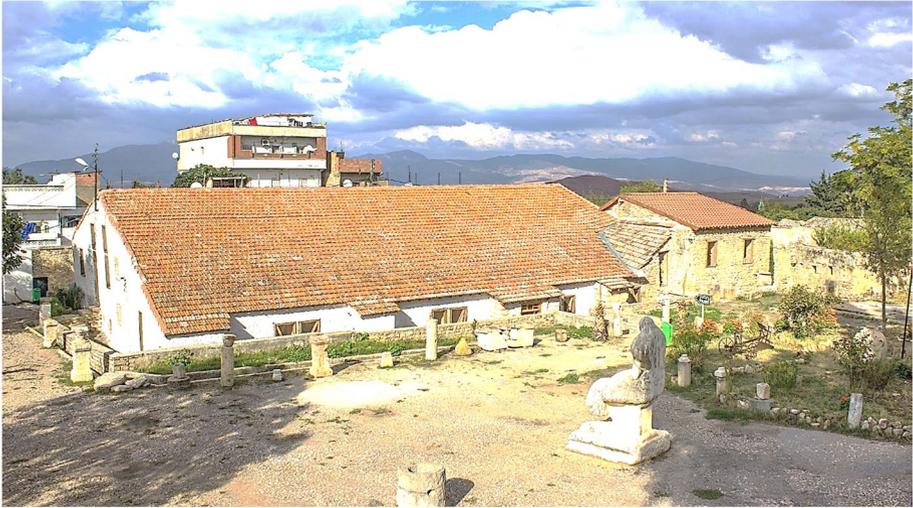
The state of disrepair of the Sidi Ghanem Mosque was worsened by the Mila earthquake. The study of the monument's restoration, which began in 2019, focused in its first

Fig. 9 North façade view of the Sidi Ghanem Mosque

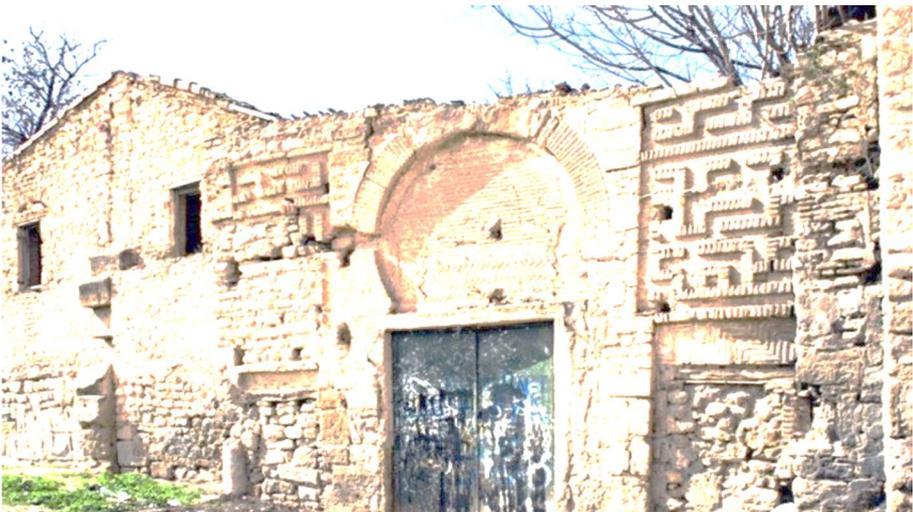
Fig. 10 South façade view of the Sidi Ghanem Mosque

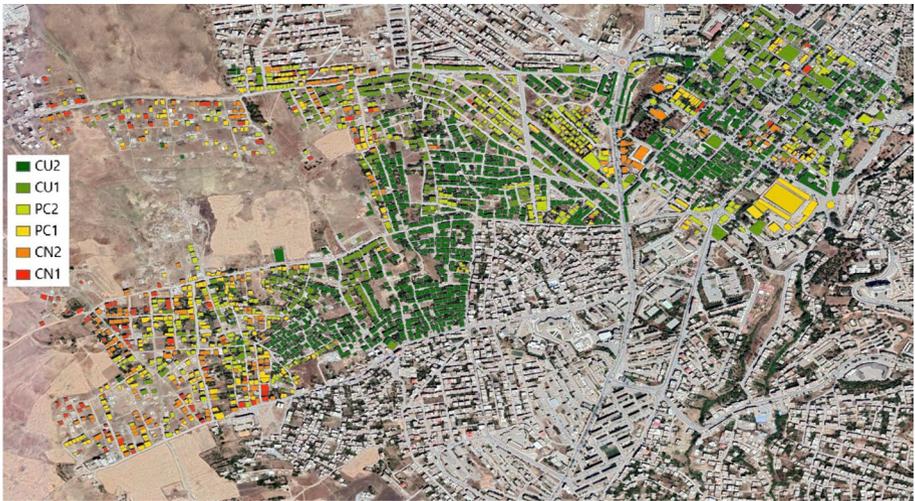
Fig. 11 A detail of Mila city's building usability rating

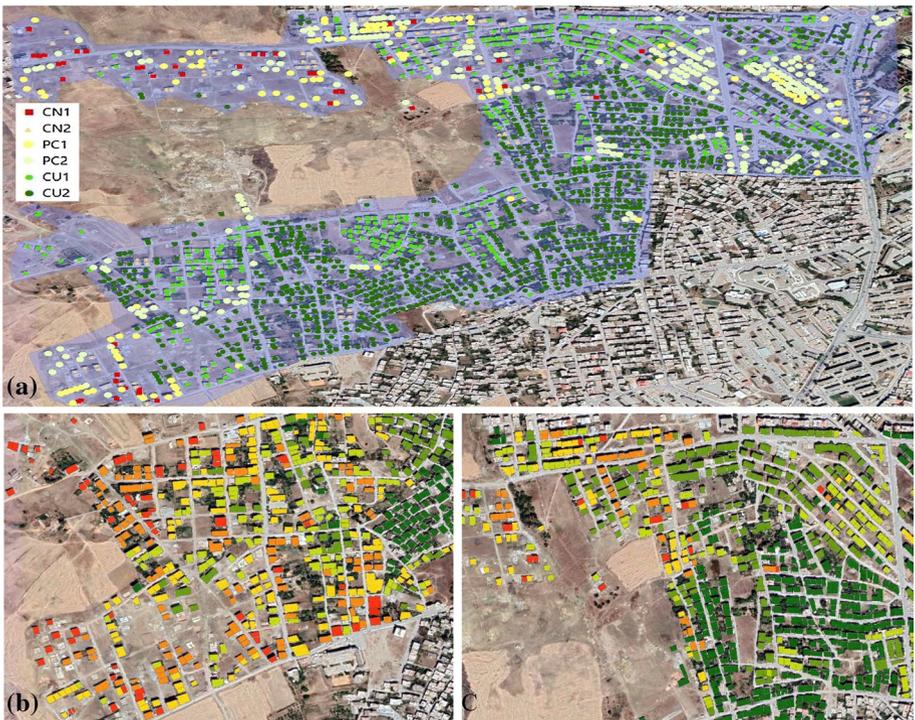
Fig. 12 Post-earthquake damage assessment for one typical block of buildings

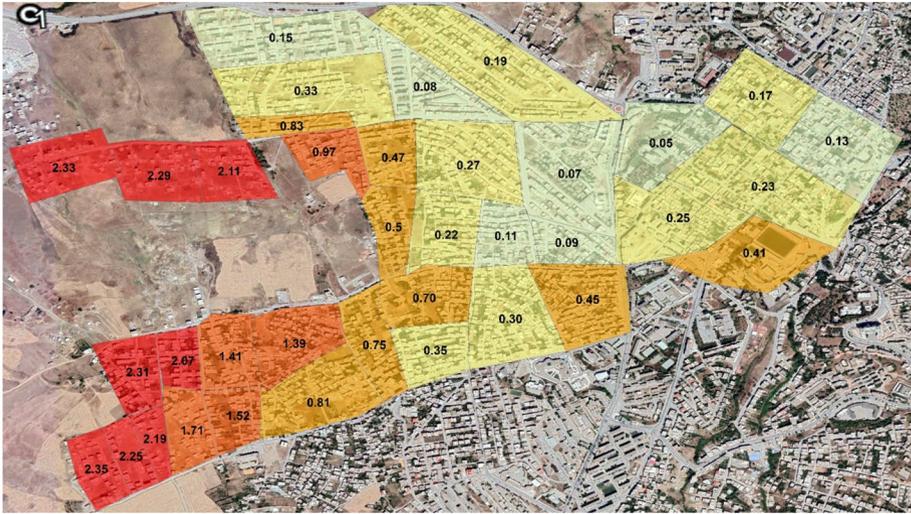
Fig. 13 Average damage index for each block of buildings

computed as a weighted average depending on the number of individual structures, as $[12 \times 0, 5(CU1) + 25 \times 1(CU2) + 40 \times 3(PCN1 + PCN2) + 9 \times 5(CN1 + CN2)]/86 = 196/86 = 2,28$.

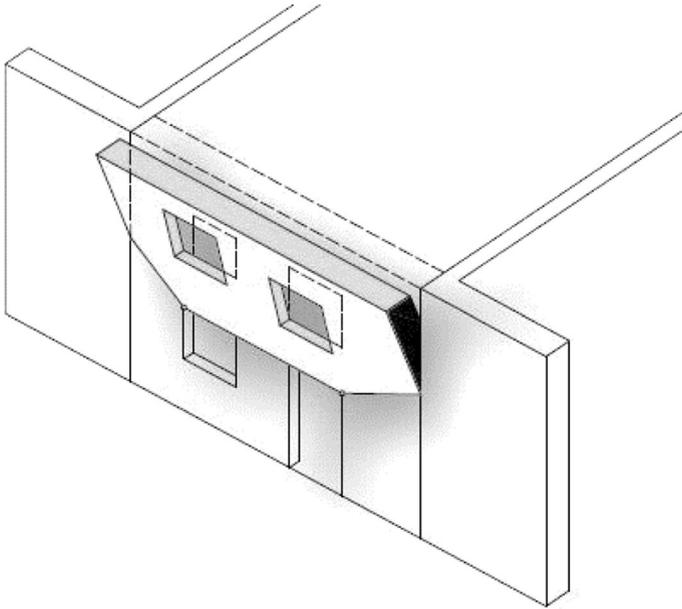
In the global study, the 3Muri software also does not take the out-of-plane loss of stability into account. It is believed that appropriate connections are created across walls and diaphragms. Out-of-plane local processes are thus avoided, allowing the global in-plane response of the structure to be studied (Lagomarsino et al. 2013). Therefore, the resistance to consolidation is put to the test in a specific program unit; specific elements of a single wall are tested, as well as the interaction of parts of many distinct walls that can generate various local mechanisms when combined. A local mechanism is seen in Fig. 35, with the mechanical component.

Fig. 35 Example of a local mechanism

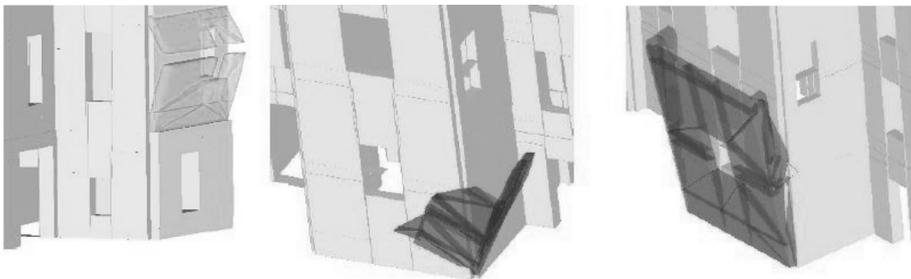
Local mechanisms are arbitrarily established based on the geometry of the building, common failure mechanisms, and seismic damage. Local mechanisms commonly emerge because of faulty wall and wall-to-floor structural connections. The linear kinematic analysis method is applied. There are three phases to defining a local mechanism. To begin, a kinematic block is a stiff wall element that is sensitive to movement or tilting in relation to another block or the whole of the wall. The initial conditions are then found, and the load is finally calculated. Several of the local progressive collapse of the apparent building, as well as its resistance to the types of failure shown, are listed below (Fig. 36 and Table 7). The ratio of the response spectrum of mechanical activation to the response spectrum of earthquake excitation is represented by the α parameter.

Fig. 36 The local mechanisms LM1 (east wing), LM2 (right wing), and LM3 (left wing) are represented in the diagram (central wing)
